03969 Version 1

Creak From the B-pillar

AFFECTED VEHICLES

Year	Model	Trim	VIN Range
2014–15	Odyssey	ALL	ALL
2016	Odyssey	ALL	5FNRL....GB000001 thru 5FNRL....GB044289

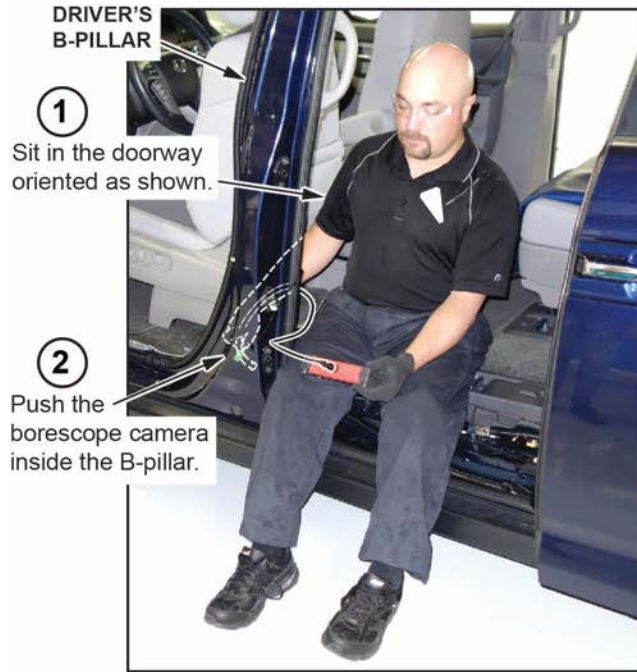
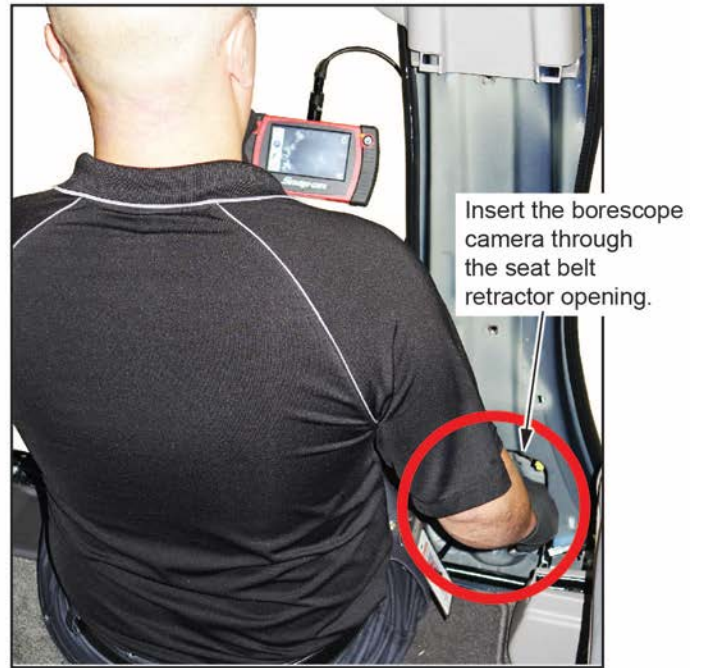
11. From a sitting position in the door opening, insert the borescope camera down into the seat belt retractor opening. Place the camera near the black plastic clip and aim toward the rear of the vehicle as shown.

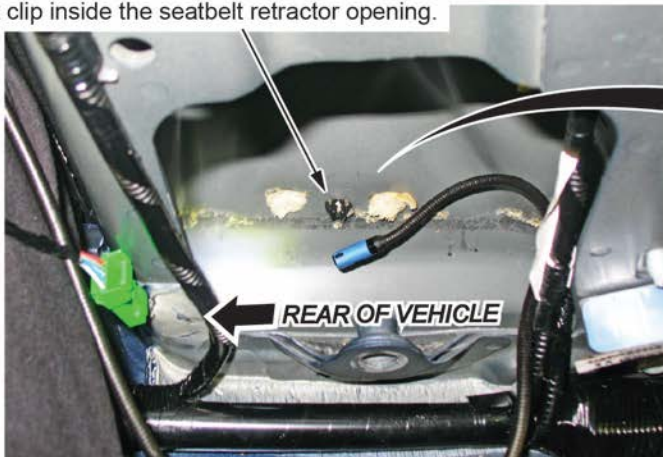
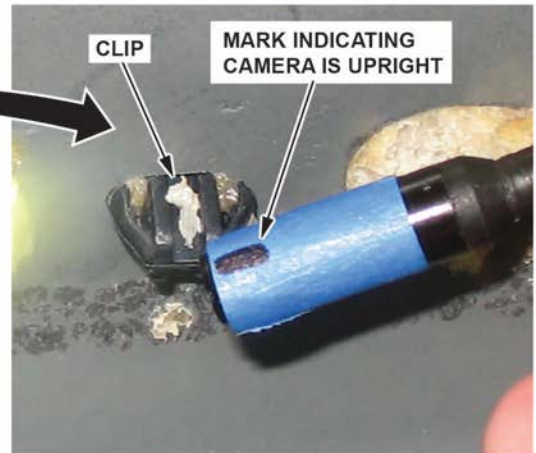
Locate the borescope camera next to the black clip inside the seatbelt retractor opening.

12. Position the camera to inspect the specified location to confirm the touch point area.

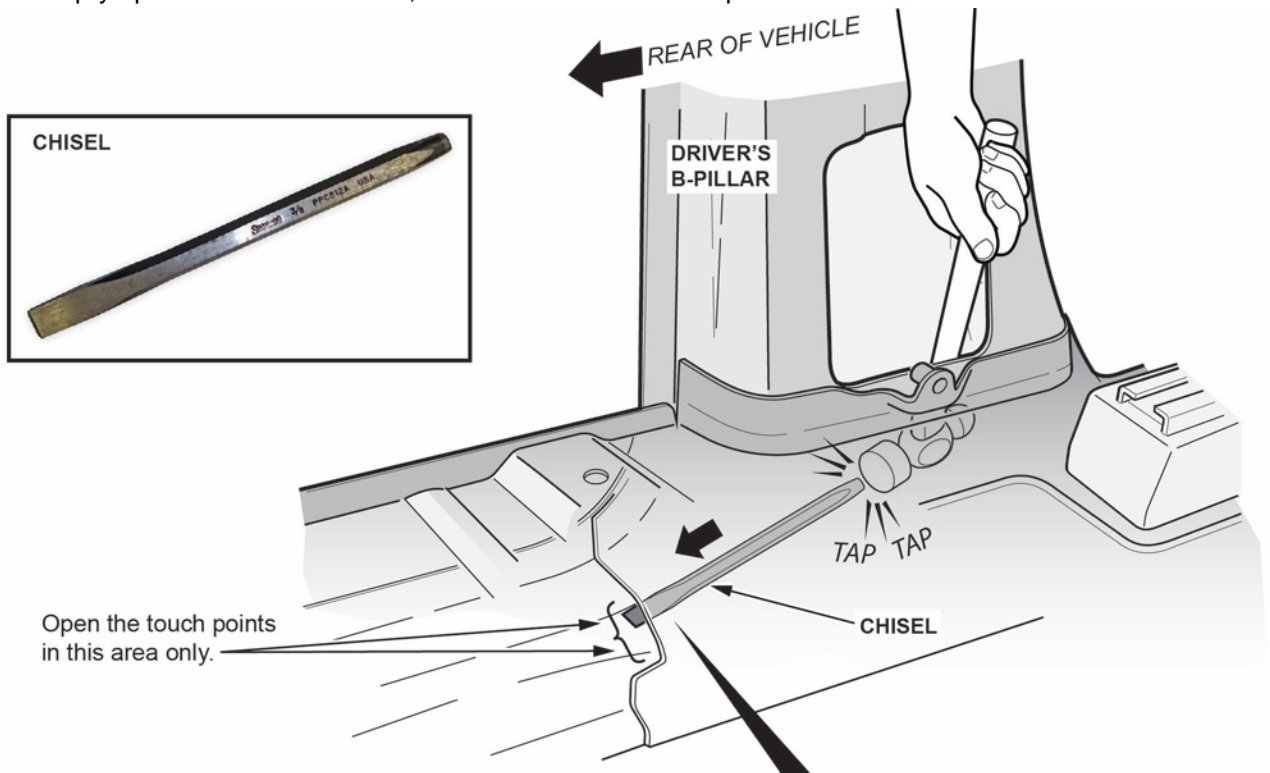
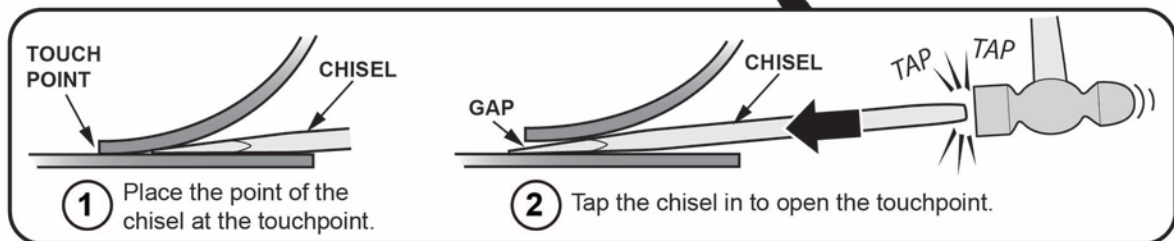
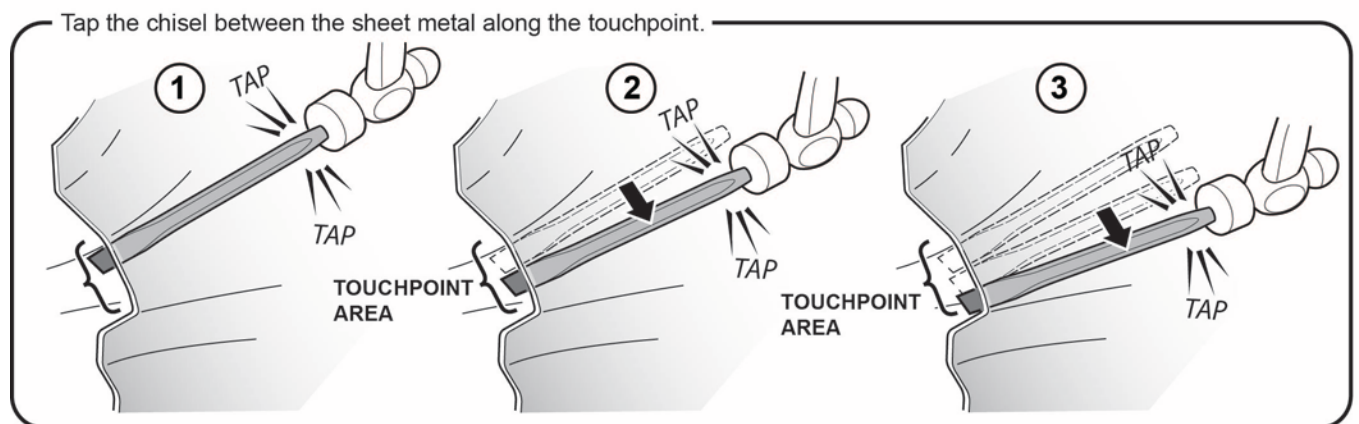
The sheet metal has a touch point deep within the base of the B-pillar.

13. Using a hammer and a small chisel, separate the sheet metal all along the touch points. Tap the chisel several times to obtain separation.

- Drive the chisel in between the sheet metal in several locations to get the proper separation along the touch point area.
- You will need to use a pry bar to remove the chisel from the B-pillar. Work it side to side to remove it.
- DO NOT pry up or down on the chisel; it could break off in the B-pillar.
