Technical Service Bulletin
No. TS 01 51816

May 18, 2016
REVISED August 24, 2016

DAMAGE TO FRONT SIDE AIRBAG HARNESS Special Warranty Extension ZH

Affected Models: Certain 2005 - 2008 Forenza and Reno Vehicles (RQ)

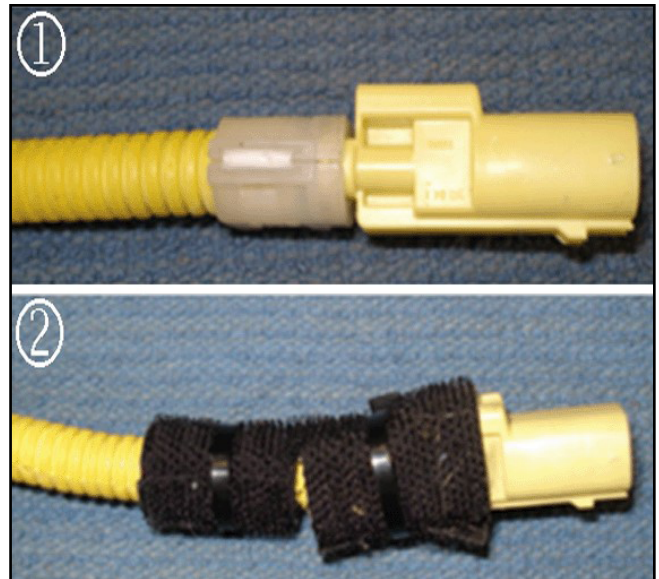
Vehicles built prior to April 7, 2006 are equipped with a white plastic conduit retainer (1) on the SAB harness at the floor harness connector.

Vehicles built after April 7, 2006 have a Velcro strap secured to the SAB connector (2). This difference will affect the final SAB harness routing procedure.
