Technical Journal

XC90 Courtesy Upgrade (C-10006)

REF NO: TJ 30991	ISSUING DEPARTMENT: Technical Service	CAR MARKET: United States and Canada	
PARTNER: 3 US 7510 Volvo Cars North America		ISSUE DATE: 2016-03-10	STATUS DATE: 2016-04-19
FUNC GROUP: 3600	FUNC DESC: Other electrical equipment	Page 1 of 10

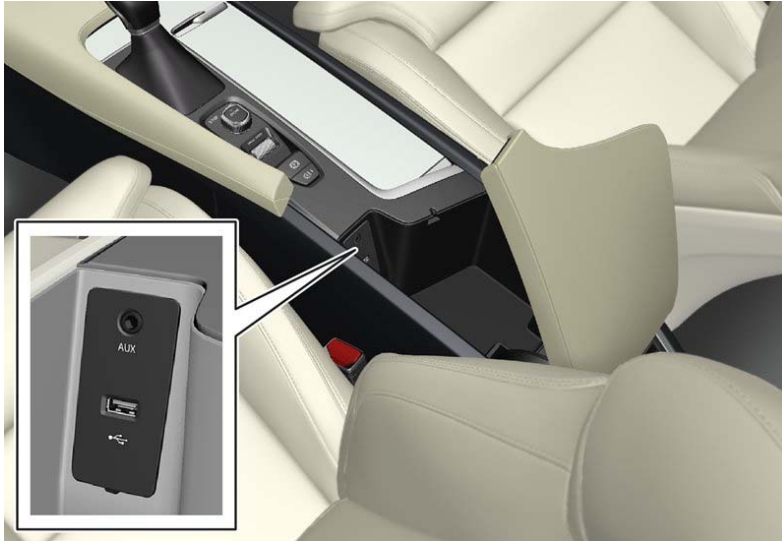
1. Switch on the infotainment system (Usage mode Convenience or higher).
Insert the USB memory stick in the USB port.

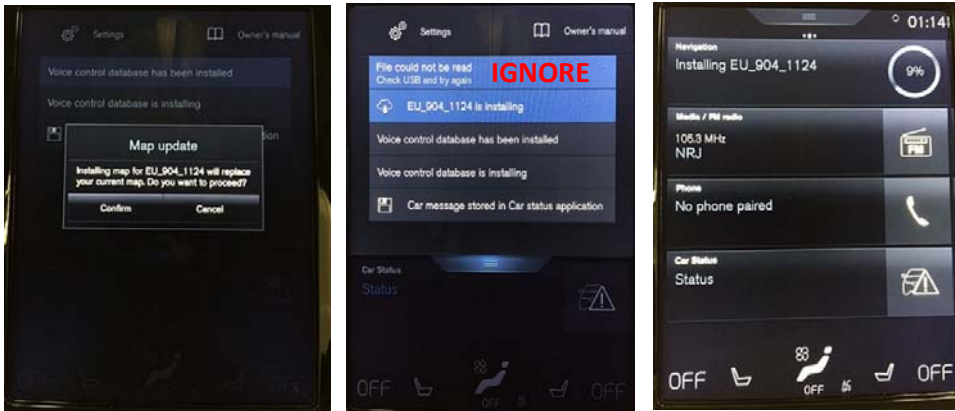
3. Maps file will start when voice control file is finished, press "Confirm".
Ignore the following message: "File could not be read. Check USB and try again".
Map data file is now being installed. This will take approximately 40 minutes.

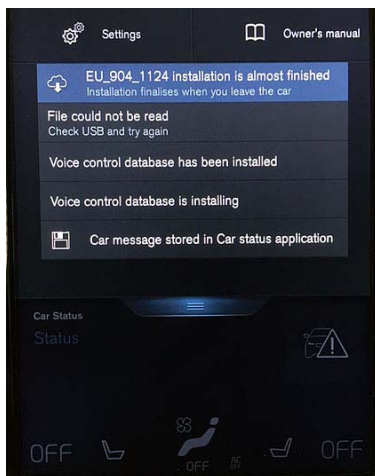
4. When the installation is complete this message is shown in top menu.
Remove the USB-stick, turn off the ignition and leave the car for 3 minutes.

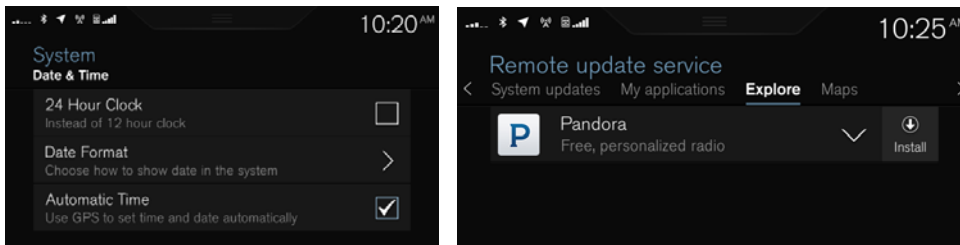
5. Start the vehicle and drive it outside so that it has a clear view of the sky.
Confirm that automatic time update is selected under Car Settings.
Within a few minutes, a GPS signal will be received and the clock time will be updated.
Download and/or Update Apps using the Remote Update Service.

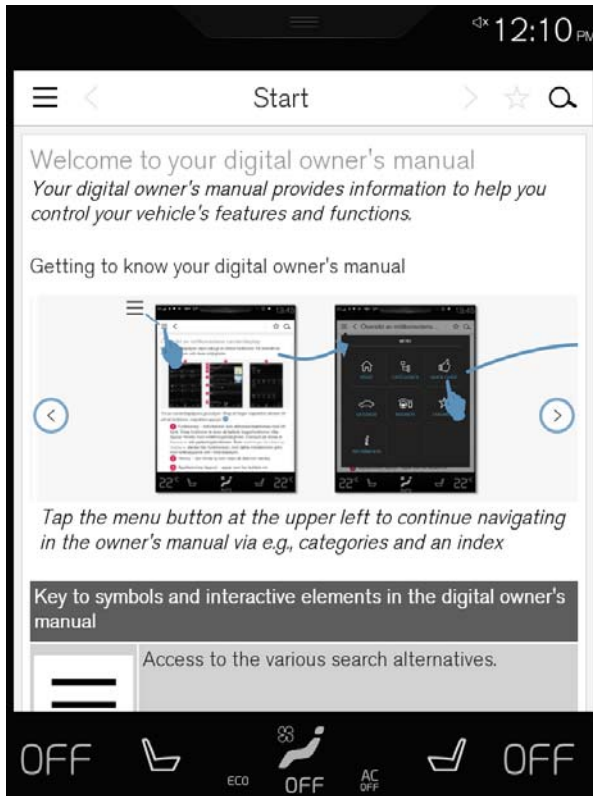
Before

Digital Owner's Manual before & after Courtesy Upgrade
