MODEL
2017MY
Sorento (UMa)

NUMBER
116

DATE
September 2016

SUBJECT: SERVICE ACTION: LANE DEPARTURE WARNING
SYSTEM DTC C180508 (SA243)

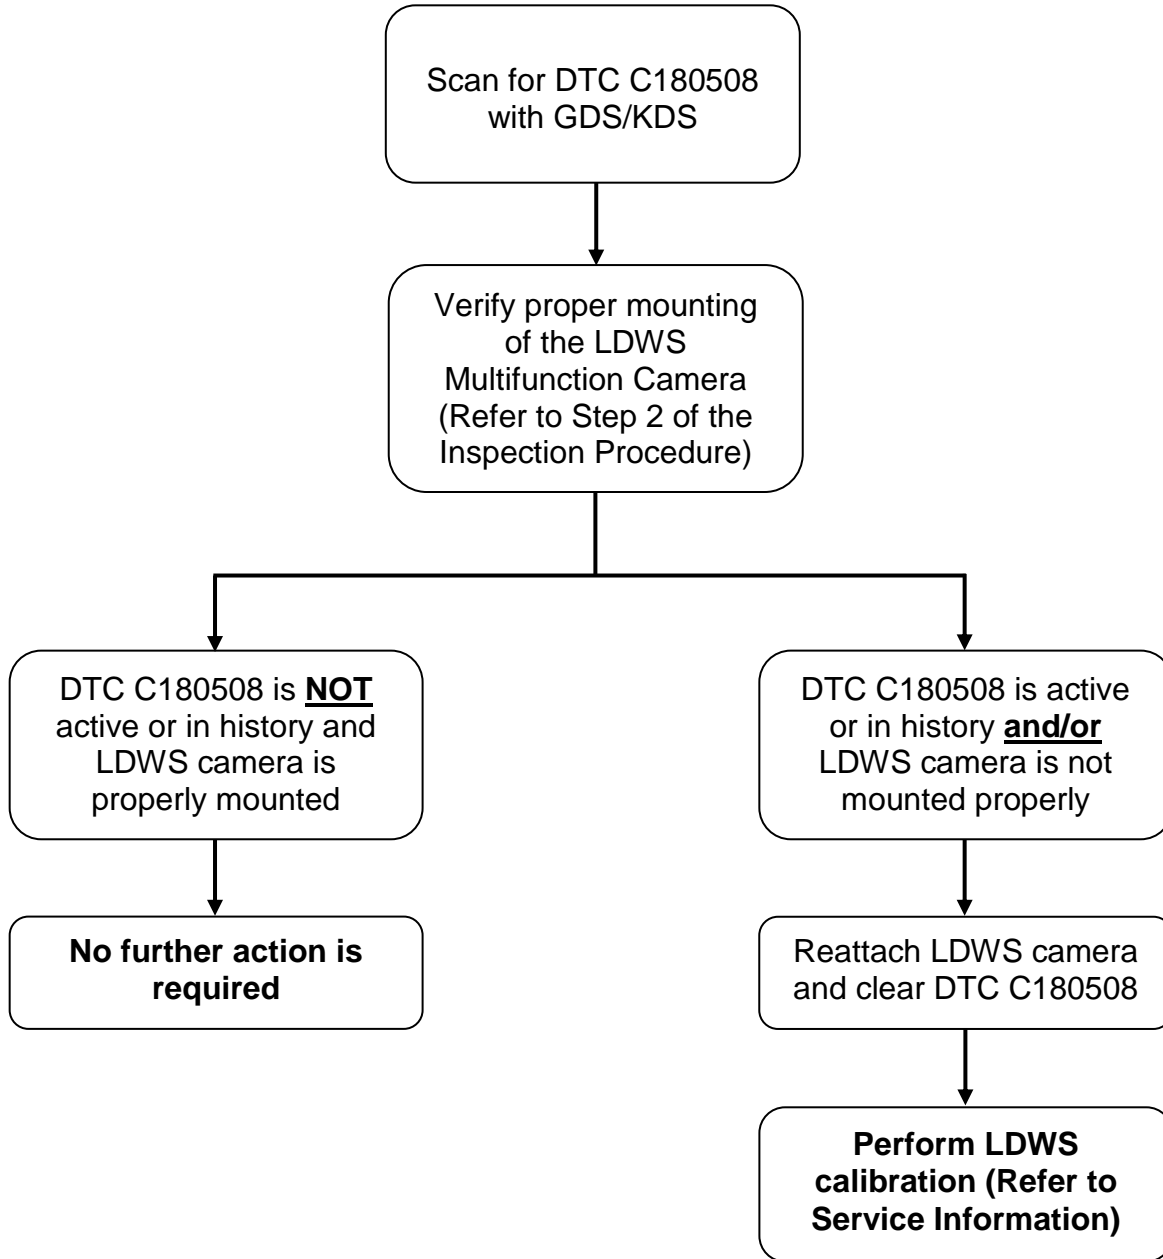
Diagnostic Flowchart:

This bulletin provides information related to the Lane Departure Warning System (LDWS) on some 2017MY Sorento (UMa) vehicles, produced from April 5, 2016 to September 10, 2016, which may exhibit a LDWS malfunction with DTC: C180508 and/or an unsecured LDWS camera. Follow the procedure below to inspect and if necessary, reattach the LDWS camera and/or calibrate the LDWS.

Do not replace the LDWS camera for this concern. Any associated claims for LDWS camera replacement are subject to review and chargeback.
