MODEL
2014~2016MY
Cadenza (VG)
2014~2015MY
Sorento (XMa) w/
3.3L GDI

NUMBER
148 (Rev 4, 9/20/2016)

TECHNICAL SERVICE BULLETIN

SUBJECT: CHATTER/RATTLE NOISE FROM ENGINE AFTER COLD SOAK

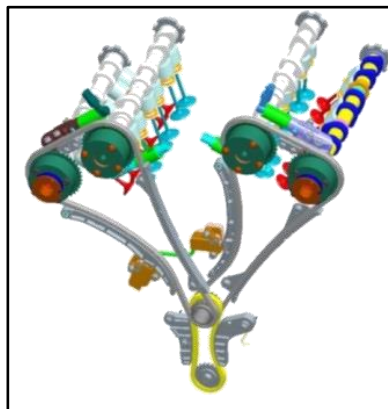
This bulletin provides information about the timing chain tensioner replacement on some 2014~16MY Cadenza (VG), produced from February 1, 2013 through January 7, 2016, and some 2014~2015MY Sorento (XMa) vehicles, produced from December 17, 2012 through December 11, 2014, which may experience a brief chattering or rattling noise concern from the engine on start-up, after a cold soak. After confirming the noise concern, follow the procedures outlined in this TSB to resolve the concern.
