2016 MAXIMA; NAVIGATION UNIT FREEZES

NTB16-067

APPLIED VEHICLE: 2016 Maxima (A36) only in the following states: California (CA), Nevada (NV), Arizona (AZ), Oregon (OR) and Utah (UT)

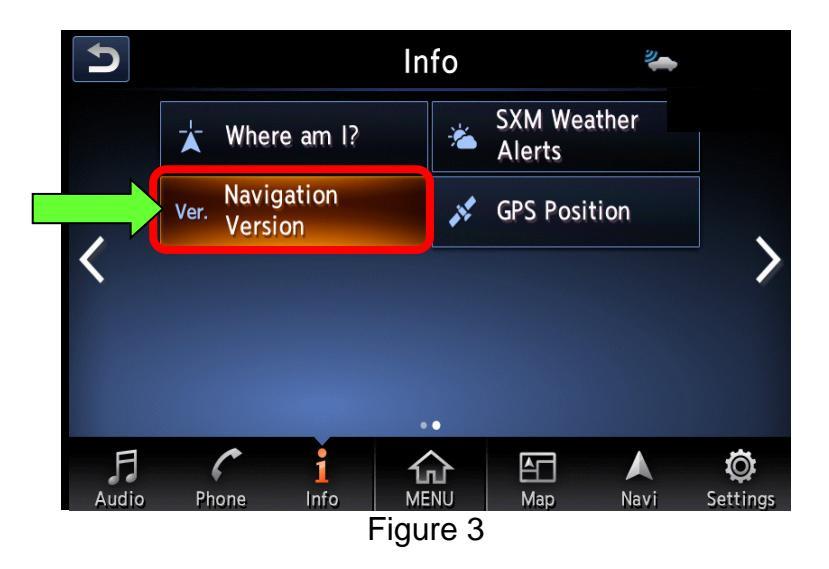
- 6. Check the Program Version number.
 - If **107** or **124**, a software update is needed.
 - Write down the values for Program Version, Unit code, and Serial number on the repair order and then go to page 5, AV Control Unit Software Update with Software Update SD Card.
 - > This information is for possible future reference.
 - If **140**, a software update has already been successfully performed.

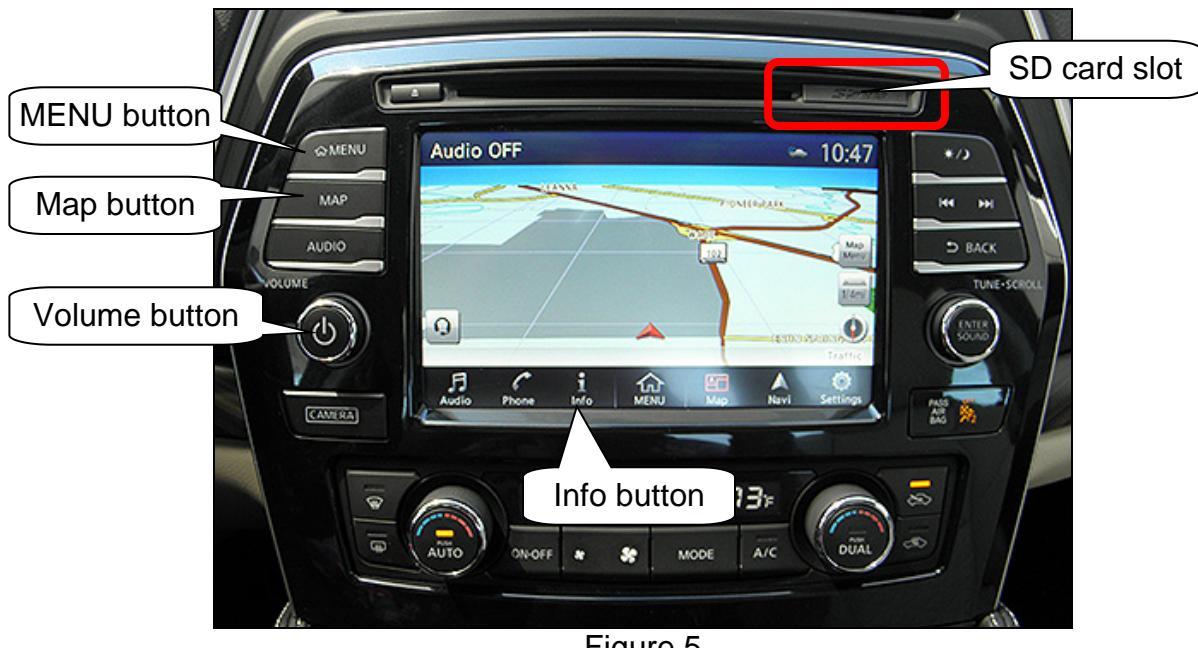
- Refer to Figure 5 below for location of controls and SD card.
- Make sure the vehicle's Map SD card (not the update card) is inserted in the SD card slot before starting the software update procedure.

- 1. Turn the hazard warning lamps ON.
 - Leave the hazard warning lamps ON until AV control unit software updating is complete.
- 2. If the navigation map does not display on its own, make it display by pressing the MAP button.
- 3. Turn the audio system OFF by pressing the volume knob, if not already OFF.
