Technical Service Bulletin

SUBJECT:		No: TSB-16-11-001	
ROCKER COVER OIL LEAK		DATE: August, 2016	
		MODEL: 2014-16 Outlander	
CIRCULATE TO:	<input type="checkbox"/> GENERAL MANAGER	<input checked="" type="checkbox"/> PARTS MANAGER	<input checked="" type="checkbox"/> TECHNICIAN
<input checked="" type="checkbox"/> SERVICE ADVISOR	<input checked="" type="checkbox"/> SERVICE MANAGER	<input checked="" type="checkbox"/> WARRANTY PROCESSOR	<input type="checkbox"/> SALES MANAGER

PURPOSE

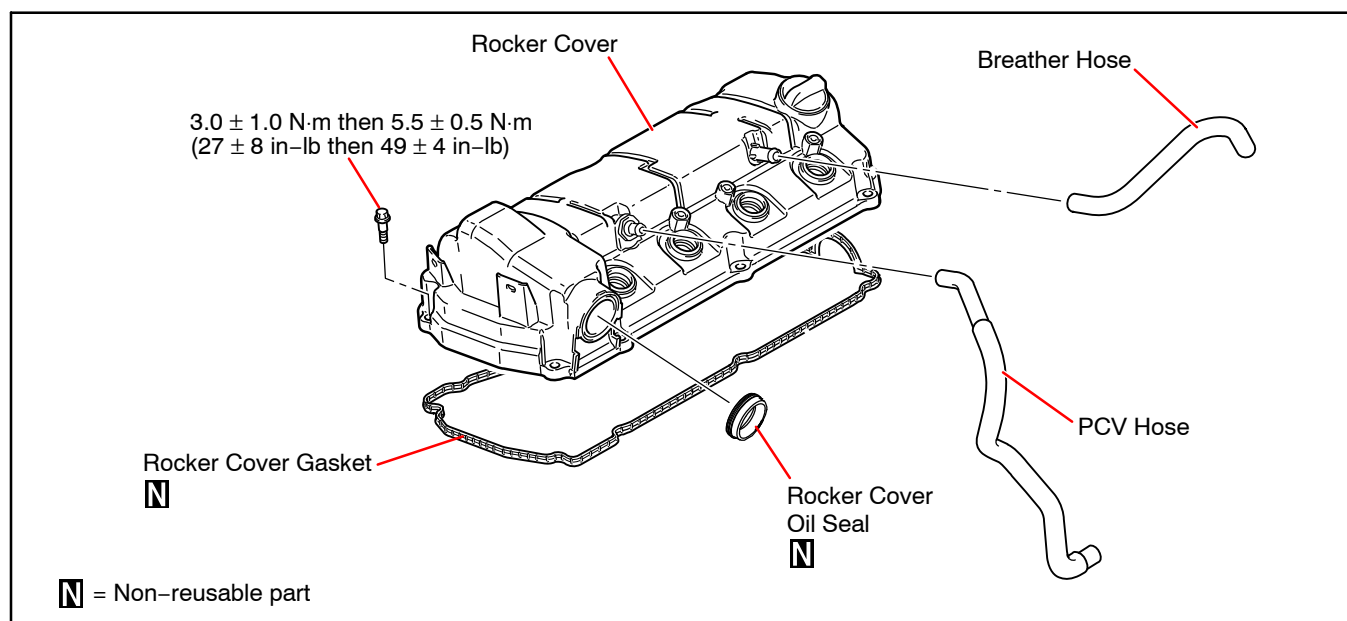
Some vehicles may exhibit an oil leak from the rocker cover. This may be caused by an insufficient quantity of FIPG (Formed in Place Gasket) applied during production. This TSB provides guidelines for reinstalling the rocker cover, including proper application of FIPG, when replacing the rocker cover gasket in the event of an oil leak.

2. Completely remove the existing liquid gasket adhering to the rocker cover, timing chain case, and cylinder head.
3. Degrease all contact areas where the gasket and liquid gasket are applied.
4. Install the new rocker cover gasket and new rocker cover oil seal onto the rocker cover.

5. Apply the liquid gasket (p/n 1000A923) paying attention to the details below.

a. Apply the liquid gasket in a uniform bead with a thickness of 4 mm (0.2 inch) diameter.

b. Apply liquid gasket at rear of engine as shown in the illustration below.

- Apply a 4 mm thick bead at the base of the arch.
- Apply a 4 mm diameter bead along the arch, about 3 mm from the edge, to a height of 20 mm above the cylinder head (View D).
- Apply a 10 mm diameter bead at the bottom of the arch as shown (View A).
