Technical Service Bulletin

SUBJECT: IMPROPER DOOR GLASS FUNCTION			No: TSB-16-42A-001
			DATE: October, 2016
			MODEL: 2013-15 Outlander Sport/RVR
CIRCULATE TO:	<input type="checkbox"/> GENERAL MANAGER	<input checked="" type="checkbox"/> PARTS MANAGER	<input checked="" type="checkbox"/> TECHNICIAN
<input checked="" type="checkbox"/> SERVICE ADVISOR	<input checked="" type="checkbox"/> SERVICE MANAGER	<input checked="" type="checkbox"/> WARRANTY PROCESSOR	<input type="checkbox"/> SALES MANAGER

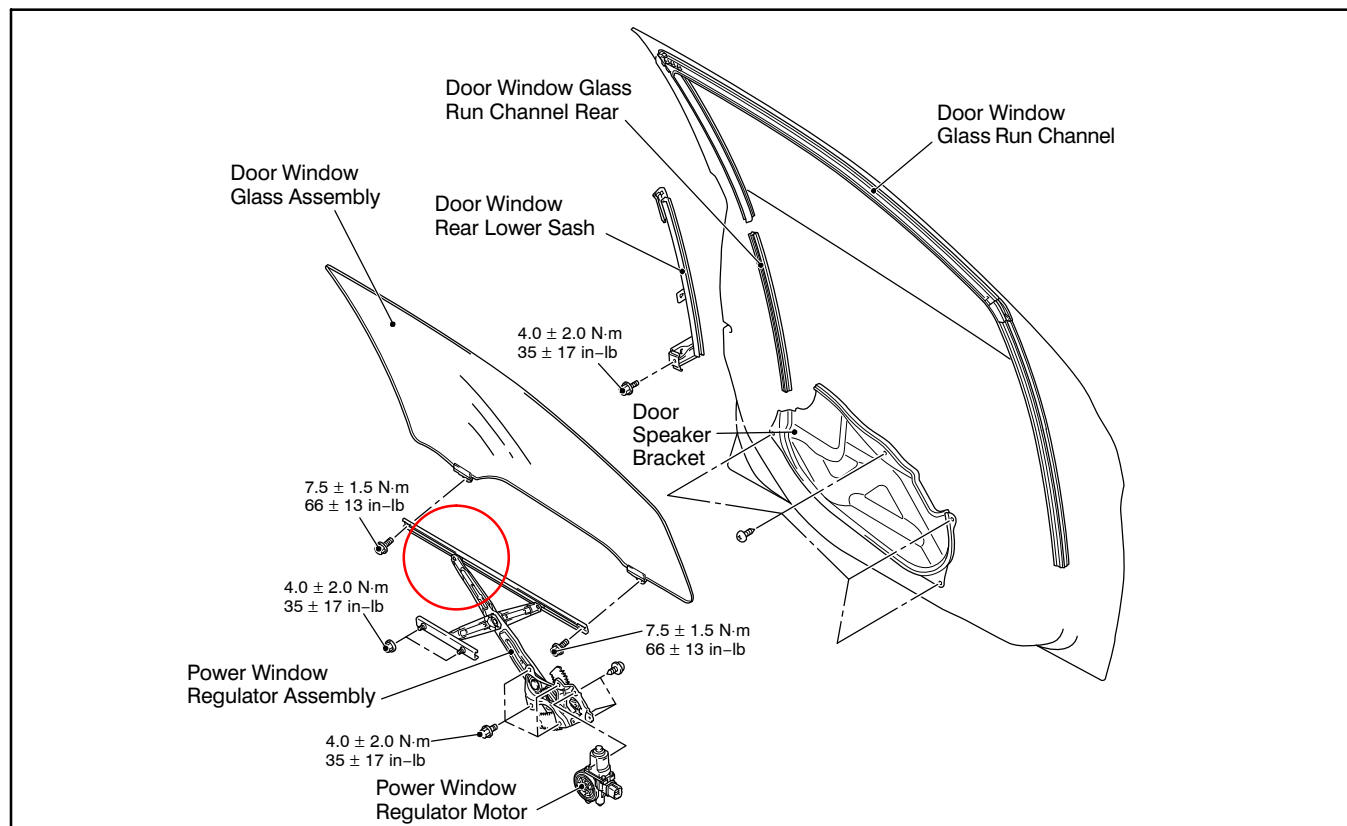
NOTE: Photos shown are of drivers door. Instructions are the same for passenger side.

1. Remove the door panel, speaker bracket (if equipped), speaker, and waterproof film to access the window regulator. Follow instructions in the Service Manual, group 42A – Door Glass and Regulator.
2. Remove the window switch from the door panel and connect to the harness so the window can be operated as needed.
