# SERVICE BULLETIN

Classification:	Reference:	Date:
EC16-026	NTB16-086	August 25, 2016

## 2013-2015 SENTRA; ENGINE TURNS OFF OR HESITATES WHEN ACCELERATING FROM A STOP DURING HOT AMBIENT TEMPERATURES (+100° F)

**APPLIED VEHICLE:** 2013-2015 Sentra (B17)

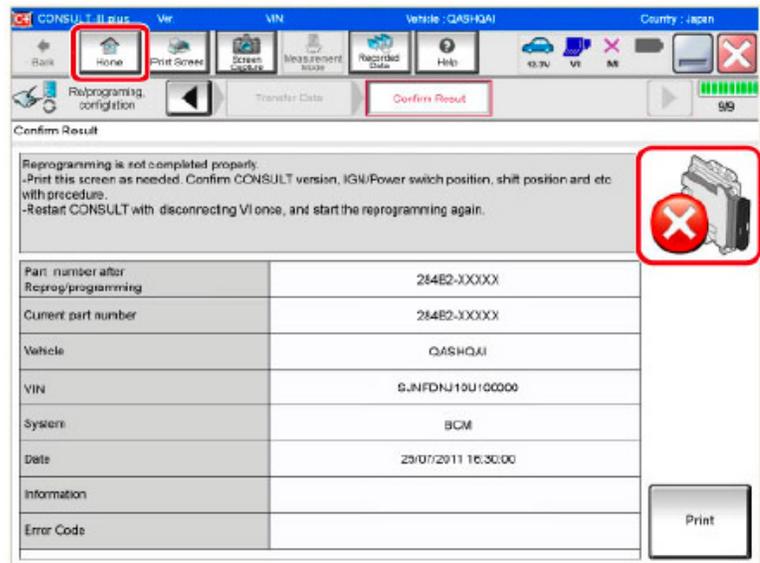
Figure 6

If reprogramming does not complete and the “X” icon displays as shown in Figure 6:

- Check battery voltage (12.0 – 15.5 V).
- CONSULT A/C adapter is plugged in.
- Ignition is ON, engine OFF.
- Transmission is in Park.
- All C-III plus / VI cables are securely connected.
- All C-III plus updates are installed.
- **Select Home, and restart the reprogram procedure from the beginning.**
