Subject: DIFFICULT TO ANCHOR CHILD SEAT ON THE REAR SEAT	Bulletin No: 09-042/16
	Last Issued: 7/1/2016

2016 CX-3 vehicles with VINs lower than JM1 DK ***** 134520 (produced before February 01, 2016)

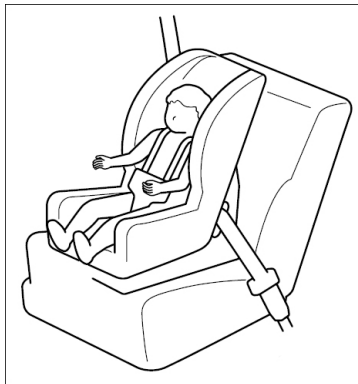
NOTE: Seat Belt “Automatic Locking Mode” may be used to secure the child seat to the rear seat prior to vehicle repair. Refer to Owner’s Manual “Essential Safety Equipment” > “Child Restraint” > “Installing Child-Restraint Systems” > “Using Automatic Locking Mode” for instructions.
