GROUP CHA	MODEL 2014~2016MY Optima Hybrid (TF HEV)
	NUMBER 067	DATE March 2016
TECHNICAL SERVICE BULLETIN		
SUBJECT: ECU UPGRADE – MIL ON WITH DTC C1356

This bulletin provides information related to an IBAU (Integrated Brake Actuation Unit) software upgrade for some 2014~2016MY Optima Hybrid (TF HEV) vehicles, produced from December 2, 2013 through July 22, 2015, which may exhibit a Malfunction Indicator Light (MIL) ON with DTC C1356 and no drivability concerns. To resolve the concern, reprogram the IBAU using the GDS/KDS download, as described in this bulletin. For confirmation that the latest reflash has been performed, verify ROM ID using the tables in this TSB.

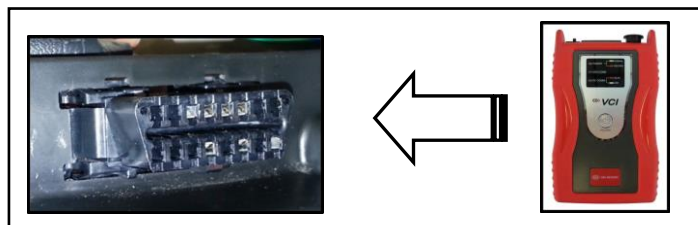
4. Connect the Main 16-pin DLC cable (GHDM – 241000) to the OBD-II connector, located under the driver's side of the instrument panel.

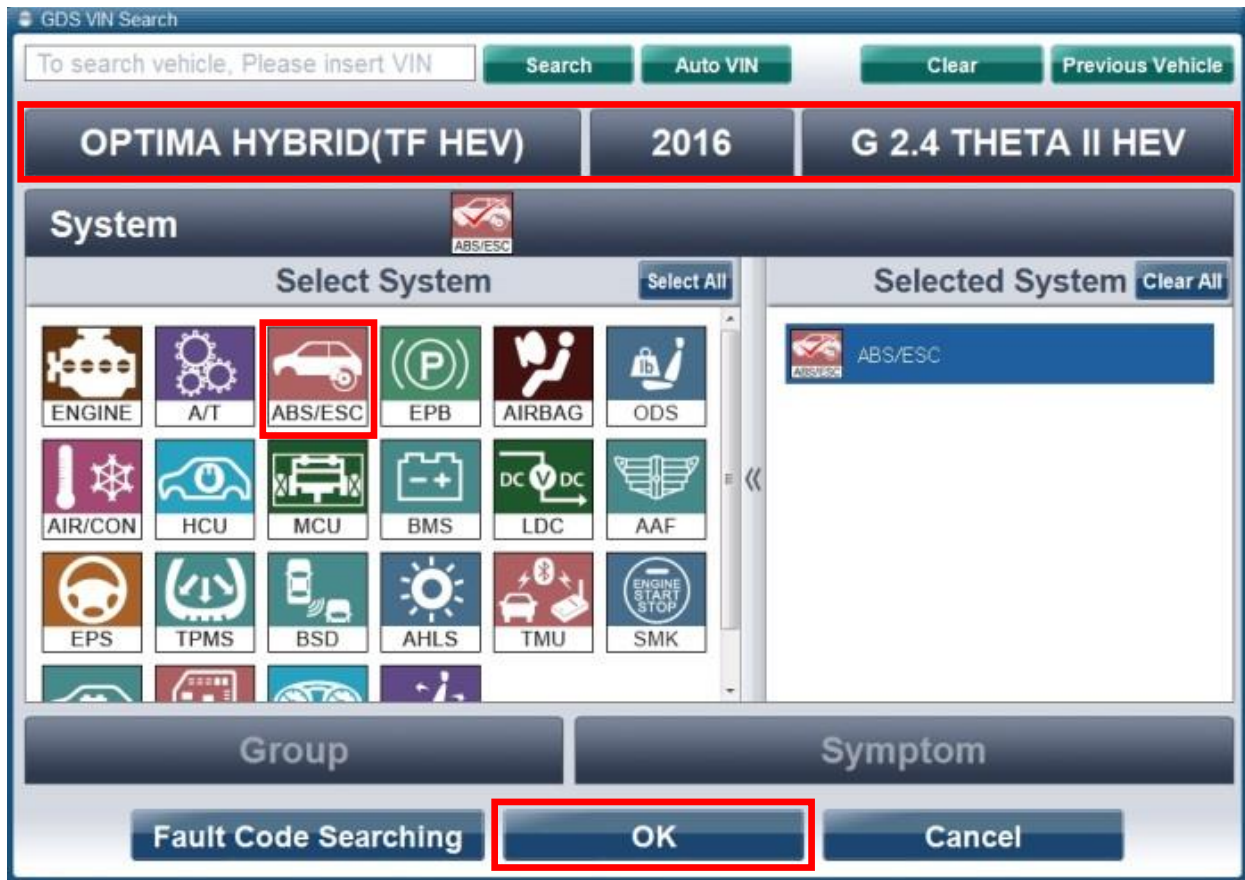
5. With the ignition key ON, turn ON the VCI and GDS. Access the GDS vehicle identification number (VIN) screen and configure the vehicle using the **VIN AUTO DETECT** Function.

- Once back at the GDS Main Screen, select ECU Upgrade from the bottom right-hand corner. Next select **Auto Mode**, and then **ABS/ESC** as the system. Perform the upgrade in accordance with normal GDS upgrade procedures.
