© 2016 Mazda Motor of America, Inc.

Subject: KNOCKING / SQUEAKING NOISE FROM FRONT SHOCK ABSORBER, CREAKING NOISE FROM FRONT LOWER ARM BUSHING	Bulletin No: 02-010/16
	Last Issued: 04/05/2016

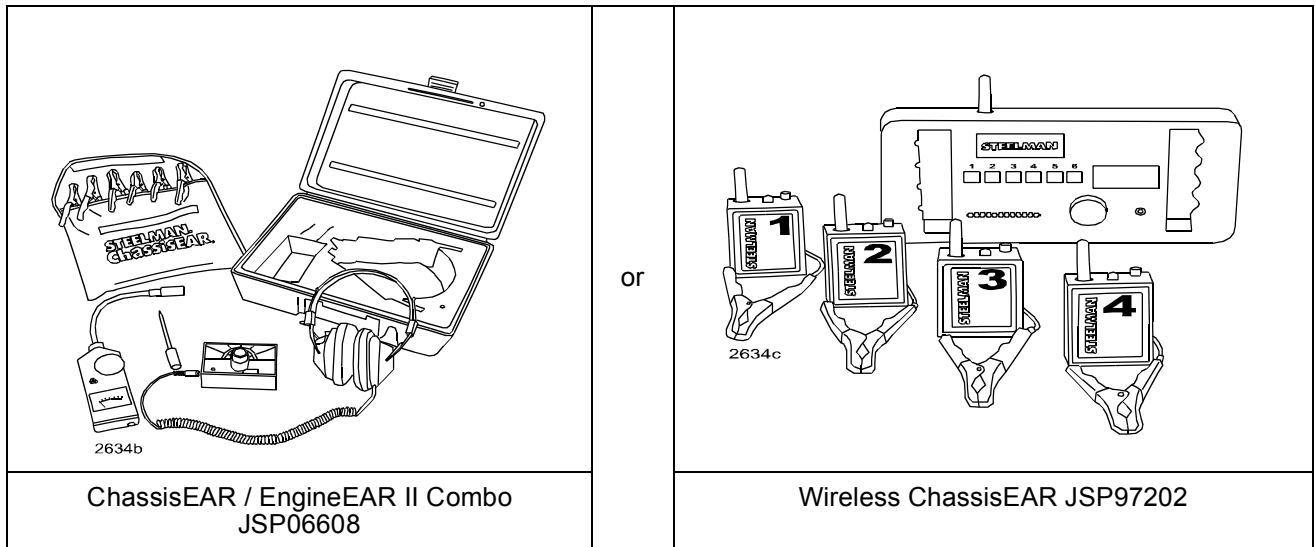
1. Use Special Service Tool (SST) ChassisEAR / EngineEAR II Combo JSP06608 or Wireless ChassisEAR JSP97202 to confirm noise is coming from the front suspension when driving over bumps and/or turning the steering wheel while the vehicle is stopped:
