| <b>Subject:</b><br><br>AIR FROM VENTS NOT COLD WITH AIR CONDITIONER ON | <b>Bulletin No:</b> 07-002/16 |
| | <b>Last Issued:</b> 05/17/2016 |

2014 Mazda3 vehicles (Mexico built) with VINs lower than 3MZBM\*\*\*\*\*174272 (produced before December 1, 2014)

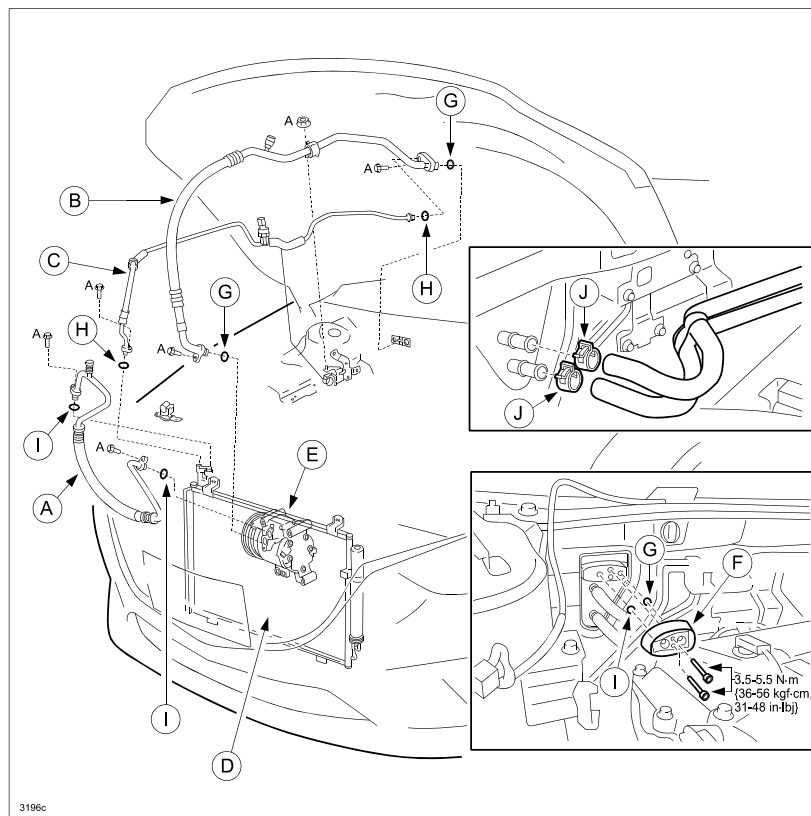
Some customers may complain that the air from the vents is not cold when the air conditioner is on. This could be caused by dust generated during polishing of the A/C pipes at production remaining in the pipes due to insufficient washing. The dust then circulates in the A/C system causing the condenser to clog and the A/C system to become inoperative. To correct the problem, the polishing process of the A/C pipes has been improved to minimize the generation of dust.

- If the refrigerant high-pressure (H) is extremely high and the refrigerant low-pressure (L) is extremely low, go to next step.
  - If the refrigerant pressure is within specification, diagnose the cause using to the Workshop Manual.
  - If the refrigerant pressure is low, refill the system and inspect for the cause of the refrigerant leak.
3. Replace the whole A/C system line with new parts according to the procedures in the following sections of the Workshop Manual.
    - A/C UNIT REMOVAL/INSTALLATION
    - A/C COMPRESSOR REMOVAL/INSTALLATION
    - CONDENSER REMOVAL/INSTALLATION
    - REFRIGERANT LINE REMOVAL/INSTALLATION
  4. Verify repair.

| Part Number | Description | Qty. | Notes |
|---|---|---|---|
| GJ6E-61-J19 | O-Ring | 3 | (I) in illustration below |
| BP4K-61-242 | Hose Clip | 2 | (J) in illustration below |
