Reference	SSM72957
Models	Range Rover / L405 Range Rover Sport / L494
Title	L405 & L494 Fuel Filling Difficult Gasoline Models Only
Category	Engine
Last modified	12-Sep-2016 00:00:00
Symptom	404000 Fuel System Concerns
Attachments	Example of vapour line restriction1.jpg (Example of vapour line restriction1.jpg) L405 & L494 fuel fill.pdf (L405 & L494 fuel fill.pdf) L405 & L494 fuel tank check valve2.pdf (L405 & L494 fuel tank check valve2.pdf)
Content	<p><u>Issue:</u></p> <p>The customer may complain of fuel filling difficulties (gas station pump premature cut off).</p> <p><u>Cause:</u></p> <p>There are a number of possible causes for fuel filling difficulties.</p> <p>Please refer to TOPIx workshop manual section '303-13: Evaporative Emissions, Diagnosis and Testing' in the first instance for advice on system checks. An example of the type of restriction which may be found in the vapour line between the fuel tank and the carbon canister is shown on the file attached "Example of vapour line restriction.jpg".</p> <p>Other Possible Causes:</p> <ol style="list-style-type: none"> 1. Debris may be lodged in the fuel filler. See page 2 of 'L405 & L494 fuel fill information.pdf' for further

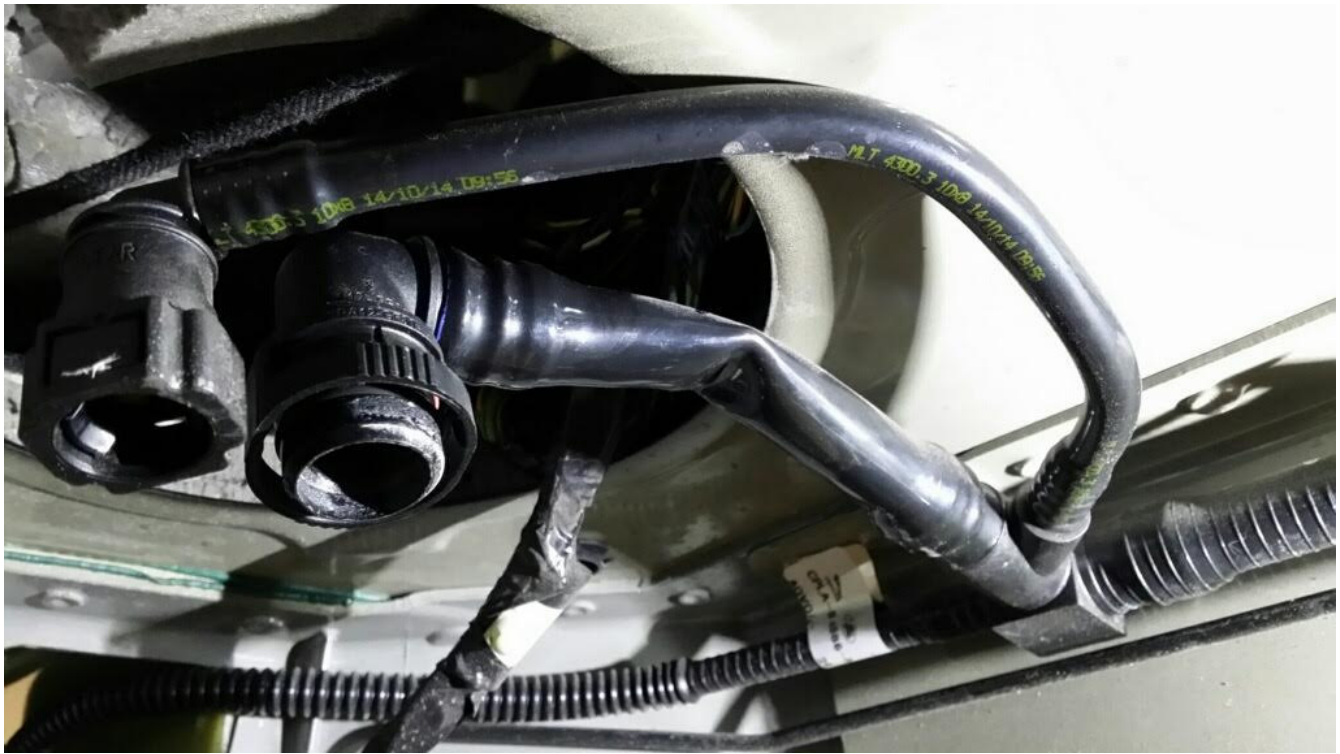
Possible Cause:

1. Debris may be lodged in the fuel filler. See page 2 for further detail.
2. The anti-siphon device (where fitted) has become dislodged. See page 3 for further detail. Note, this device is only specified for E85 flex fuel vehicles.
3. The fuel filler head under the filler cap is installed in the incorrect orientation. See page 4 for further information.
4. The check valve on the fuel tank where the fuel filler pipe connects may be obscured by a fuel pipe inside the tank.
 - See page 5 for further detail.
 - Refer to the file attached (L405 & L494 fuel tank check valve.pdf) for additional information.

Action:

- ONLY REPLACE THE FUEL FILLER IF A CLEAR FAULT IS OBSERVED. REPORT THE FAULT FOUND ON AN EPQR.
- If cause 1 is identified, correctly install the anti-siphon device.
- If cause 2 is identified, replace the fuel filler pipe (ensure the filler head is in the correct orientation on the new part).
- If cause 3 is identified, reroute the fuel pipe in the tank to prevent the check valve from being obstructed. Also take care to ensure the fuel sender is not obstructed.
- Fill with fuel and to confirm if the issue is repaired.
