December 6, 2016

05398 Version 3

## Safety Recall: TSX Rear Wire Harness

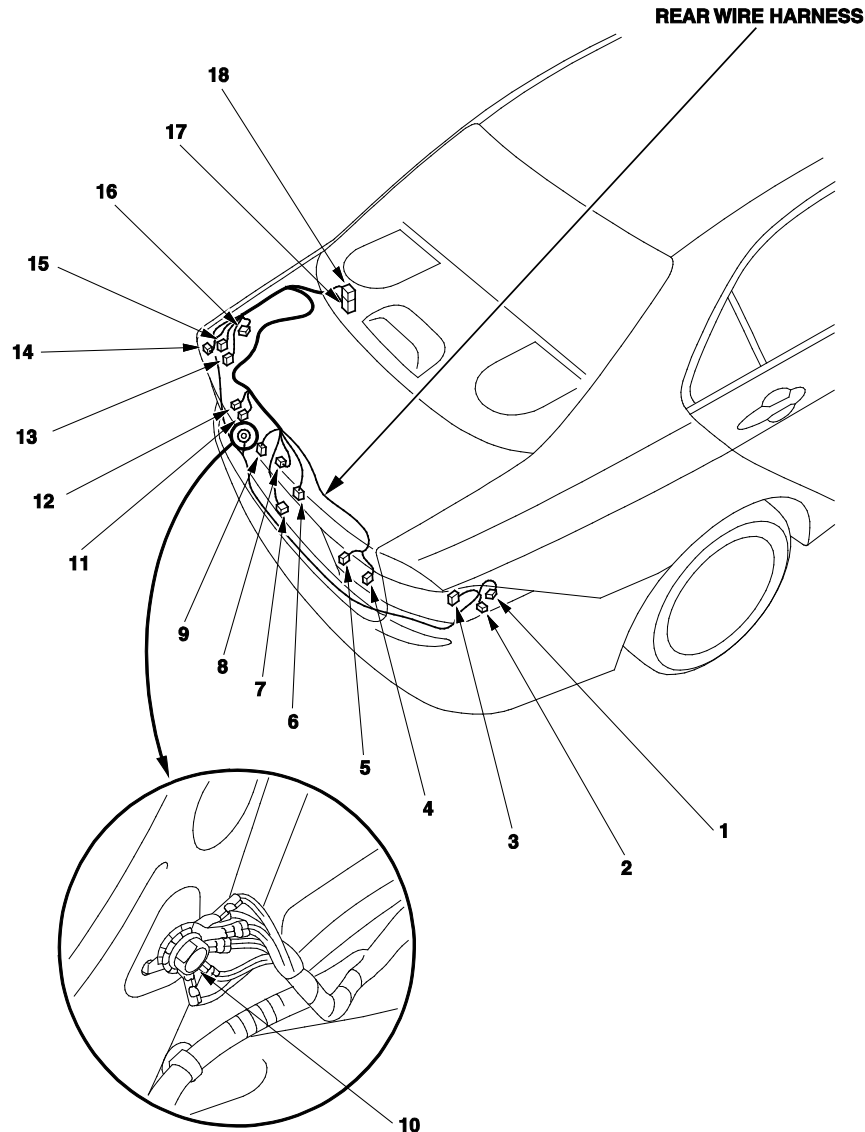
Ref	Connector or Terminal	Cavities/ Color	Location	Connects to	Notes
1	Right rear turn signal light	3-GRY	Right side of trunk	Body ground via rear wire harness	
2	Right rear side marker light	2-GRY	Right side of trunk		
3	Right brake light/taillight	4-GRY	Right side of trunk		
4	Right inner taillight	2-BLK	Right side of trunk lid		
5	Right back-up light	3-GRY	Right side of trunk lid		
6	License plate light connector B	2-GRY	Middle of trunk lid		
7	Trunk latch switch	3-GRY	Middle of trunk lid		
8	Trunk lid opener switch	2-BLU	Middle of trunk lid		
9	License plate light connector A	2-GRY	Middle of trunk lid		
10	G701		Left side of trunk		
11	Left back-up light	3-GRY	Left side of trunk lid	Rear junction block	
12	Left inner taillight	2-BLK	Left side of trunk lid		
13	Left brake light/taillight	4-GRY	Left side of trunk		
14	Left rear side marker light	2-GRY	Left side of trunk		
15	Left rear turn signal light	3-GRY	Left side of trunk

16	Trailer lighting connector	2-GRY	Left side of trunk		
17	C703 (Junction connector)	10-WHT	Left side of trunk		
18	C702 (Junction connector)	14-WHT	Left side of trunk
