**November 3, 2016**

05097 Version 2

**Creak From the B-pillar**

(Supersedes 16-035, Dated July 23, 2016, to revise the information highlighted in yellow)

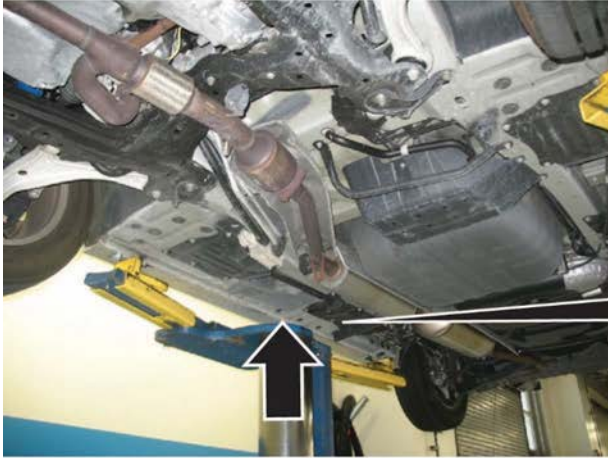
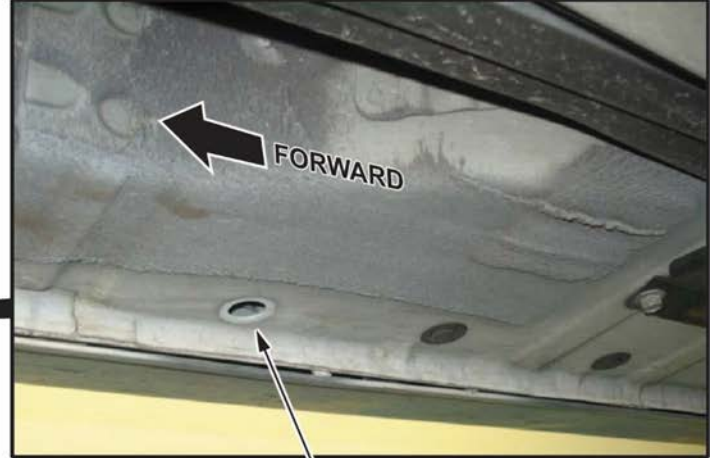
Remove the front grommet.

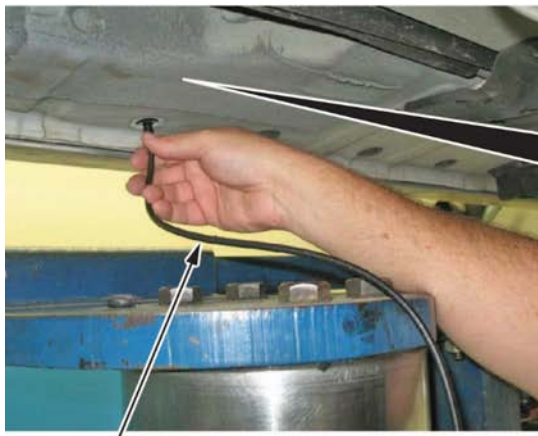
3. Use a borescope to look straight up into the hole.
  - If the bulkhead tab is touching the outer side panel, go to **REPAIR PROCEDURE A.**
  - If the bulkhead tab is not touching the outer side panel, go to **REPAIR PROCEDURE B.**

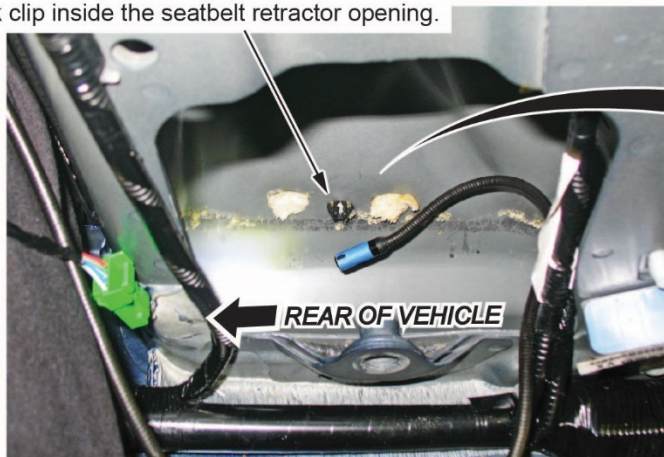
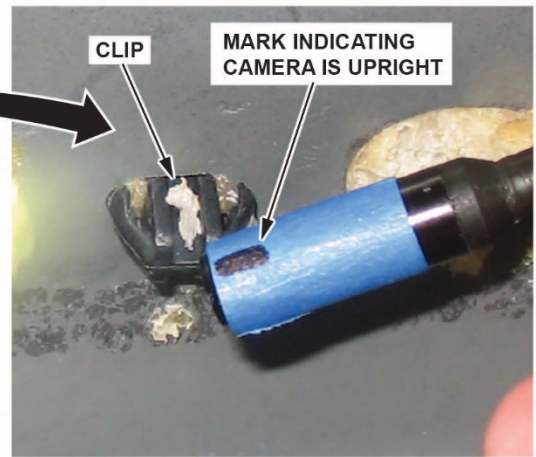
Locate the borescope camera next to the black clip inside the seatbelt retractor opening.

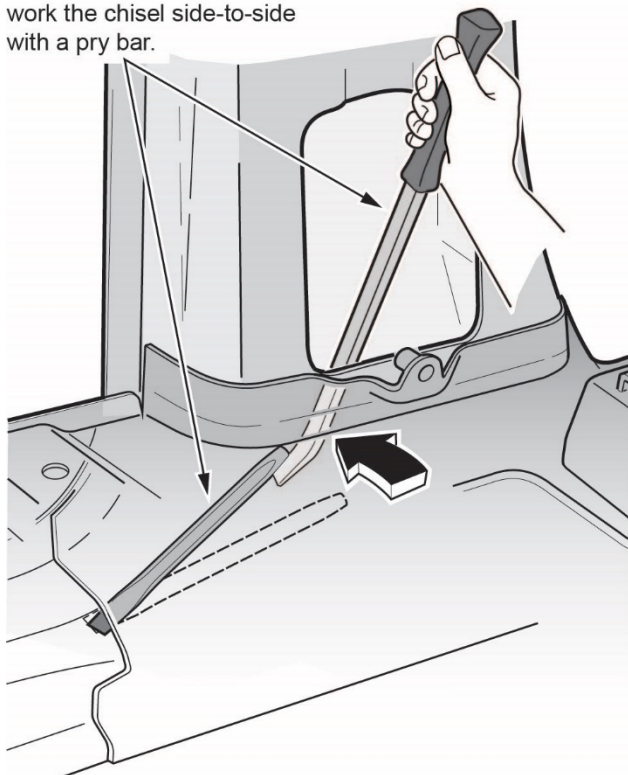
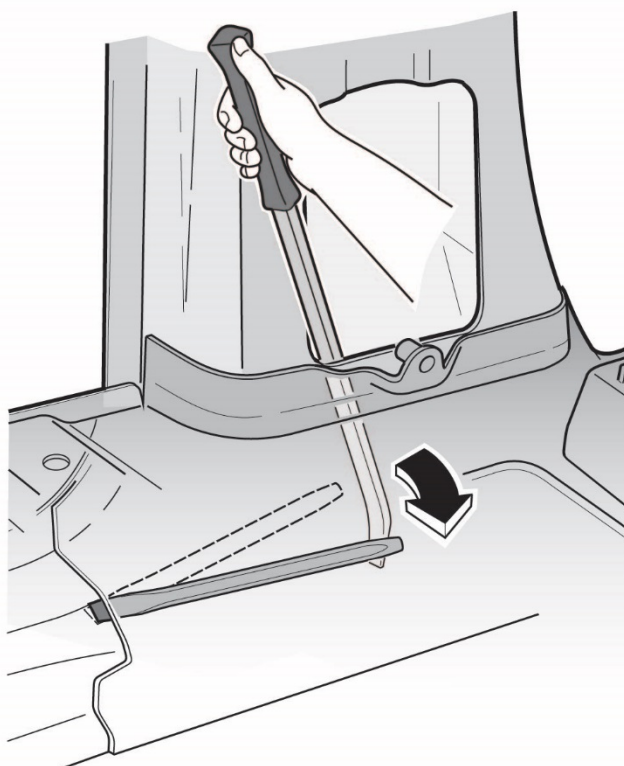
To release the chisel, work the chisel side-to-side with a pry bar.

13. Using a hammer and a small chisel, separate the sheet metal all along the touch points. Tap the chisel several times to obtain separation.
