TECHNICAL BULLETIN
LTB00648NAS2
26 JAN 2016

Harness Repair Terminal Block C44-R2

Range Rover (LG)

Model Year: 2013-2014
VIN: 108006-127685
Assembly Plant: Solihull

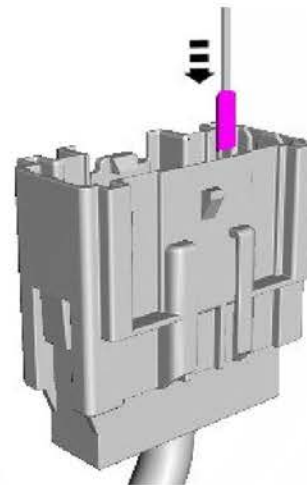
E185854

2 Hold the terminal and support the weight of the connector and harness.

- If the terminal holds in the connector (✓), the terminal is good.
- If the terminal separates from the connector (✗), the terminal in the connector must be replaced.

1 With the connector in a vertical position, install a terminal from the terminal repair kit.
