Reference	SSM72584
Models	Discovery Sport / L550 Range Rover Evoque / L538
Title	2.0L GTDi Check Engine Light Illuminated with DTC P2096 and or P2097 Stored in PCM
Category	Driveability
Last modified	11-Jan-2016 00:00:00
Symptom	698298 Malfunction Indicator Lamp
Attachments	High-Pressure Diagnostic Leak Detector Information1.pdf (High-Pressure Diagnostic Leak Detector Information1.pdf)

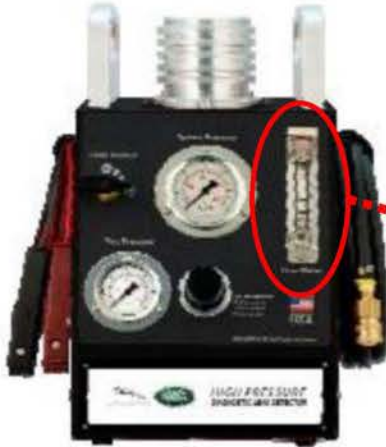
High-Pressure Diagnostic Leak Detector

Flow rate is visible on the test equipment on the front right hand side. The mid-point / widest point of the float, is the reference point to be used, when reading the value. Please record this value for submission on either TA or EPQR.
