CAMPAIGN BULLETIN

Automatic Transmission Dealer Inventory

Reference: PC562
Date: April 6, 2017

PC562 – TITAN (A61G, 4WD) MULTI-POINT INSPECTION

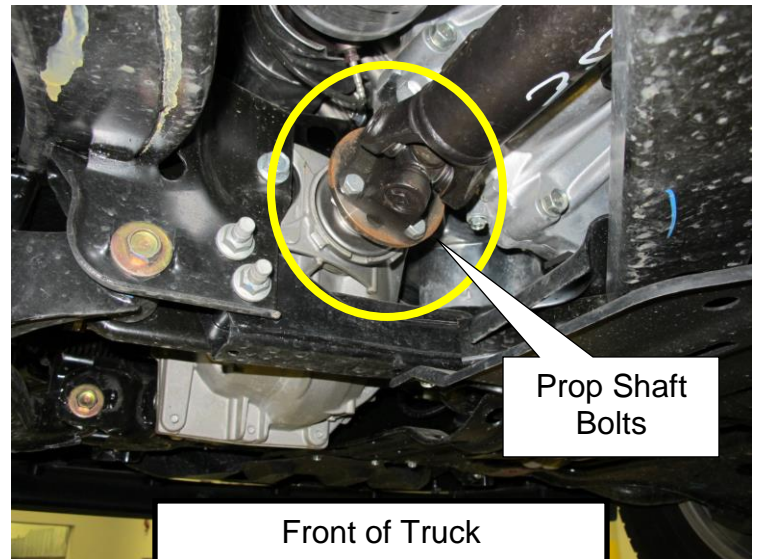
Figure 1

1. Locate the (4) front prop shaft bolts at the front differential (Figure 1).

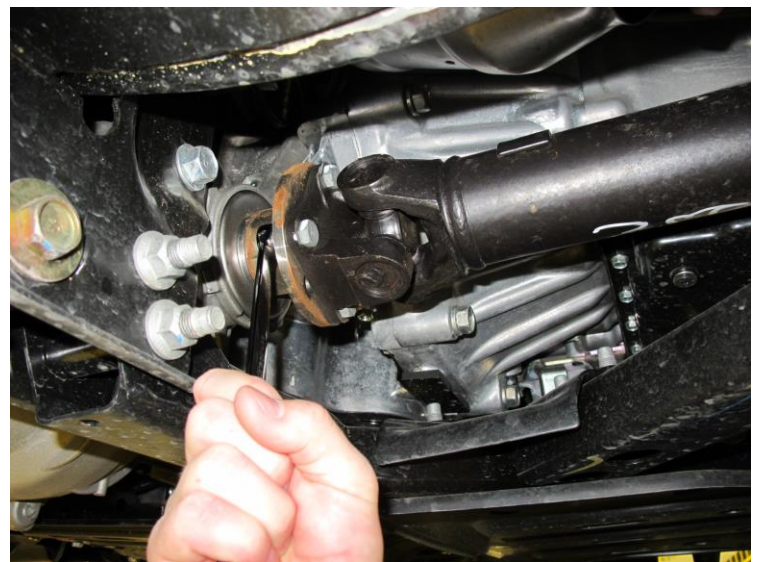
Figure 2

2. Place a 14MM box end wrench on one of the inside nuts, while holding the Prop Shaft in place apply LIGHT to MODERATE force, repeat on the other bolts. (Figure 2):
 - A. If **any** of the bolts move (NOT the prop shaft) **replace all 4** of the front prop shaft bolts and nuts, (see Parts Information below).
 - Torque NEW Front Prop Shaft bolts and nuts:
59.8N·m (44 ft-lb)
 - B. If bolts do not move (are tight) go to Inspection 4.
3. Once Inspection is complete and all bolts have been checked for torque and/or replaced, move to Inspection 4.

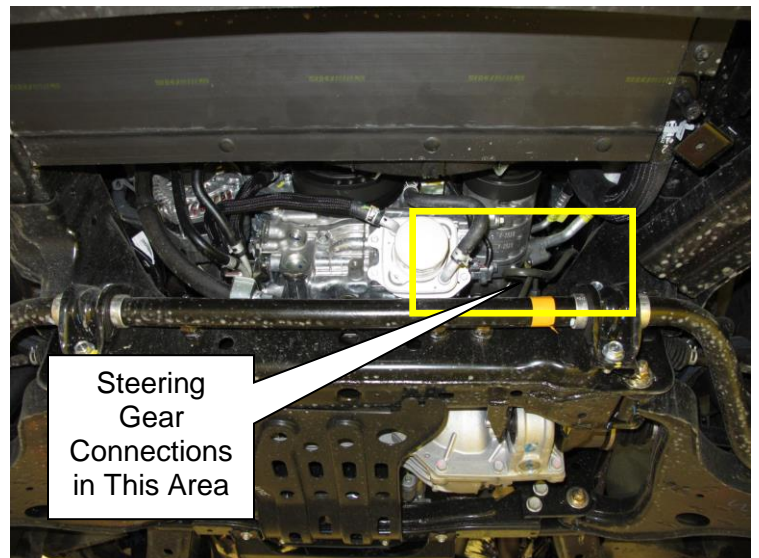
Figure 2

2. Locate the steering gear (rack & pinion) connections for the Power Steering Oil Return Pipe Assembly and Power Steering Oil Pressure Hose Assembly (Figure 2, 3).

3. Inspect for **LEAKS** between the Steering Gear and Power Steering Oil Return Pipe and Power Steering Oil Pressure Hose connections (Figure 3).

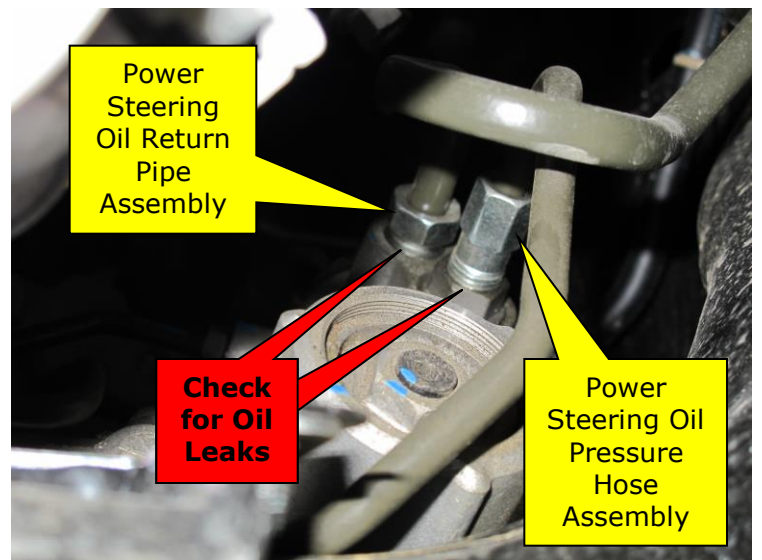
Figure 5

6. Inspect for **LEAKS** again between the Steering Gear and Power Steering Oil Return Pipe and Power Steering Oil Pressure Hose connections (Figure 5).
