CAMPAIGN BULLETIN

Automatic Transmission Dealer Inventory

Reference: PC563

PC563 – TITAN XD (A61G, 2WD) MULTI-POINT INSPECTION

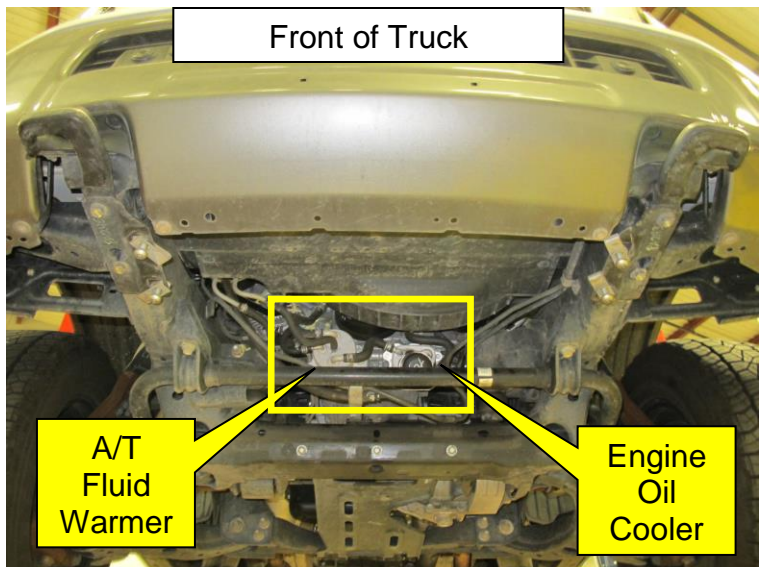
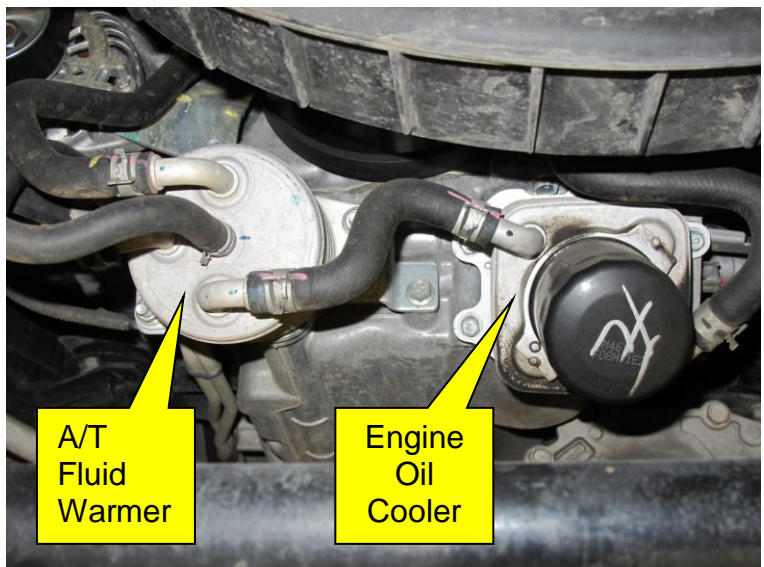
Figure 4

5. Locate the A/T fluid warmer and Engine Oil Cooler at the front of the oil pan (Figure 4, 5).

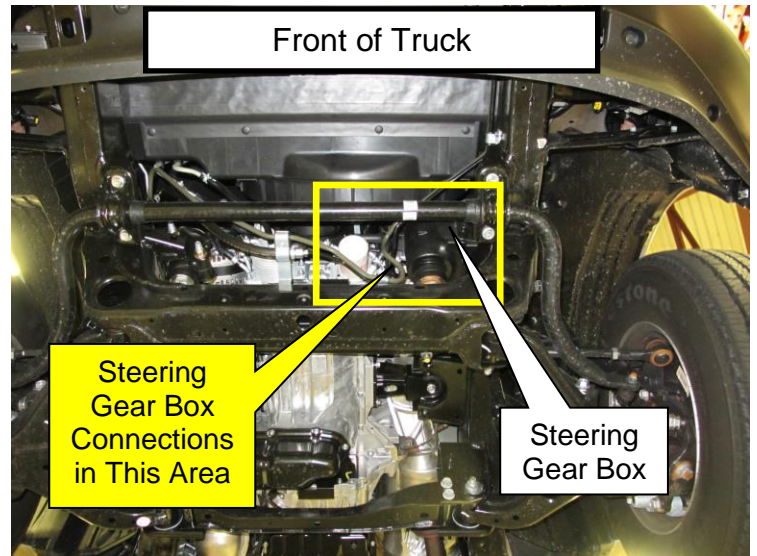
Figure 1

1. Locate the power steering box connections for the Power Steering Hose Assembly (Pressure) and Power Steering Hose Assembly (Return). (Figure 1, 2, 3).

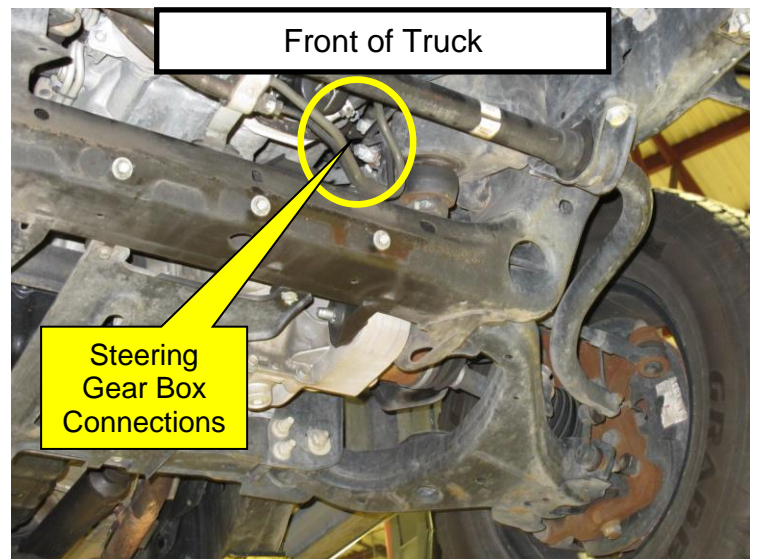
Figure 2

Note: 4WD shown, 2WD similar (Figure 2).

2. Inspect for **LEAKS** between the Steering Gear Box and Power Steering Hose Assembly (Pressure) and Power Steering Hose Assembly (Return) connections. (Figure 3).

- If **NO LEAK** found, inspection is complete, proceed to step 9 to install front under cover.
- If **LEAK** found, proceed to step 3.
