CAMPAIGN BULLETIN

Automatic Transmission Dealer Inventory

Reference: PC564
Date: April 28, 2017

PC564 – TITAN XD (A61G, 4WD) MULTI-POINT INSPECTION

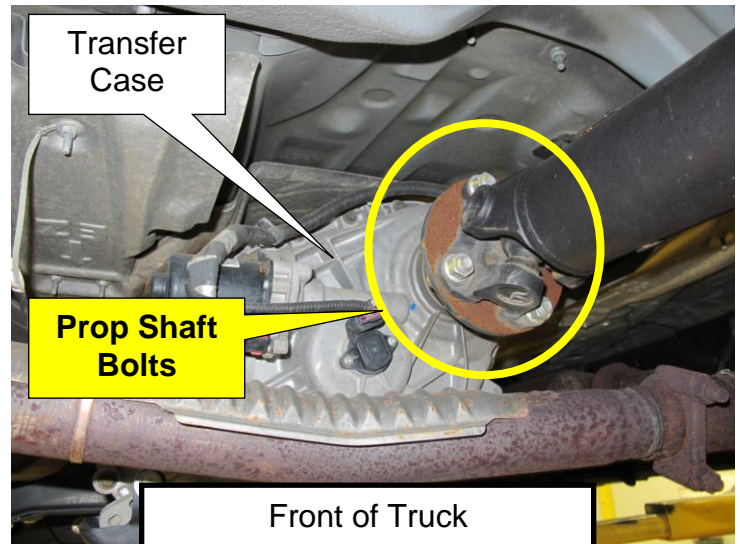
Figure 1

1. Locate the (4) rear prop shaft bolts at the transfer case (Figure 1).

2. Using a suitable tool apply LIGHT to MODERATE force to one of the 19MM bolts, repeat on the other bolts (Figure 2).

A. If **any** of the bolts move (NOT the prop shaft) **replace all 4** of the rear prop shaft bolts and nuts, (see Parts Information).

- Torque NEW Rear Prop Shaft bolts and nuts:
105N·m (77 ft-lb)

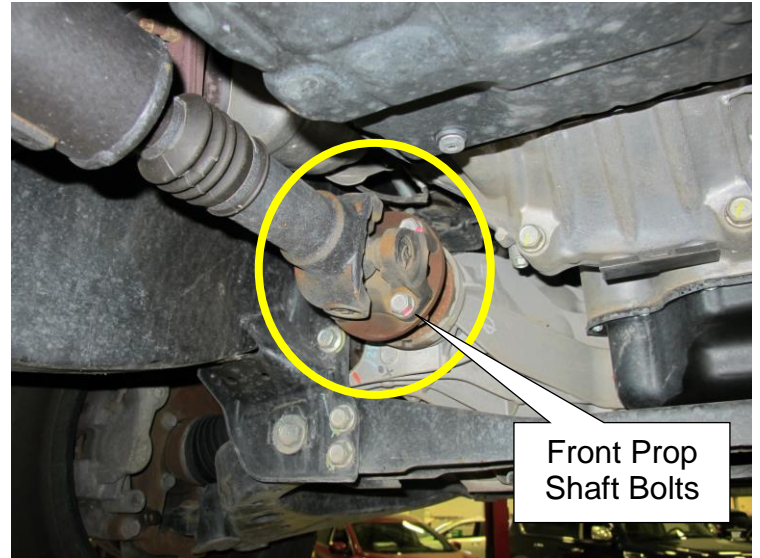
Figure 1

1. Locate the (4) front prop shaft bolts at the front differential (Figure 1).

2. Place a 17MM box end wrench on one of the inside nuts, while holding the Prop Shaft in place apply LIGHT to MODERATE force, repeat on the other bolts. (Figure 2):
 - A. If **any** of the bolts move (NOT the prop shaft) **replace all 4** of the front prop shaft bolts and nuts, (see Parts Information).
 - Torque NEW Front Prop Shaft bolts and nuts:
80N·m (59 ft-lb)
 - B. If bolts do not move (are tight) go to Inspection 4.

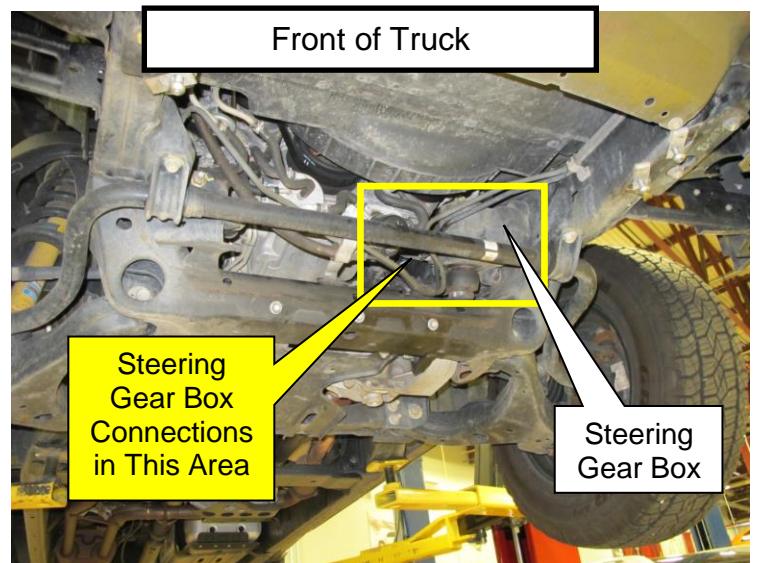
Figure 1

1. Locate the power steering box connections for the Power Steering Hose Assembly (Pressure) and Power Steering Hose Assembly (Return). (Figure 1, 2, 3).

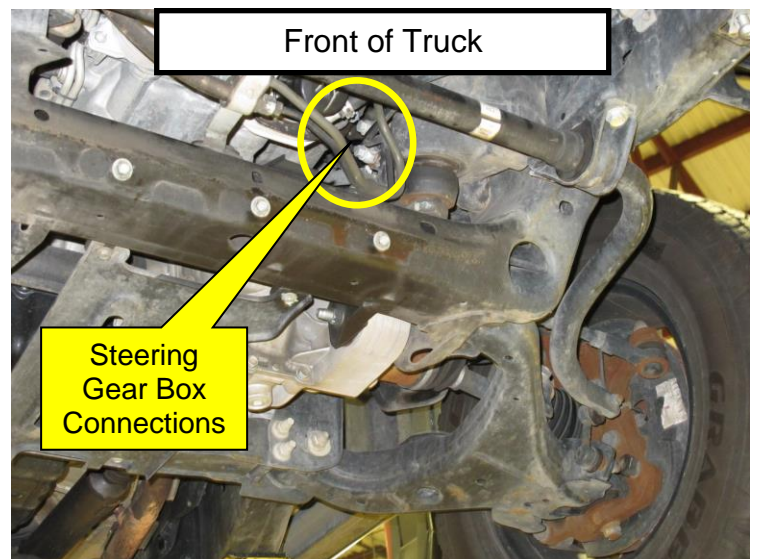
Figure 2

2. Inspect for **LEAKS** between the Steering Gear Box and Power Steering Hose Assembly (Pressure) and Power Steering Hose Assembly (Return) connections. (Figure 3).

- If **NO LEAK** found, inspection is complete, proceed to step 12 to install front under cover.
- If **LEAK** found, proceed to step 3.
