CAMPAIGN BULLETIN

Automatic Transmission Dealer Inventory

Reference: PC565
Date: April 28, 2017

PC565 – TITAN XD (A61D, 2WD) MULTI-POINT INSPECTION

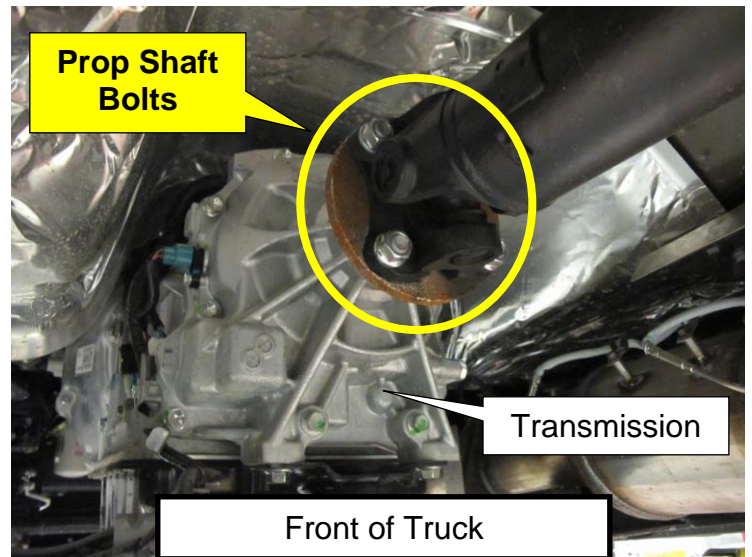
Figure 1

1. Locate the (4) rear prop shaft bolts at the transfer case (Figure 1).

A. If **any** of the nuts move (NOT the prop shaft) **replace all 4** of the rear prop shaft bolts and nuts, (see Parts Information below).

- Torque NEW Rear Prop Shaft bolts and nuts:
105N·m (77 ft-lb)

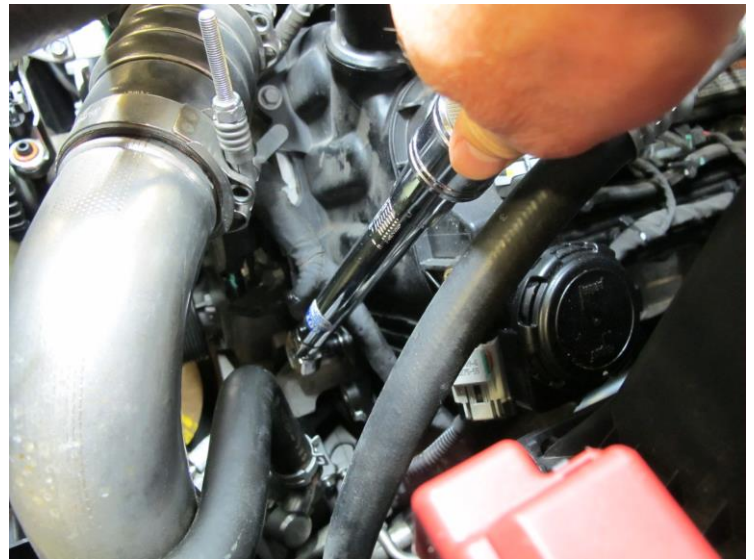
Figure 9

6. Locate the power steering oil pump bracket and the three 12MM bolts (Figure 7, 8).

7. Torque the three pump bracket bolts (Figure 9): **28N·m (21 ft-lb)**

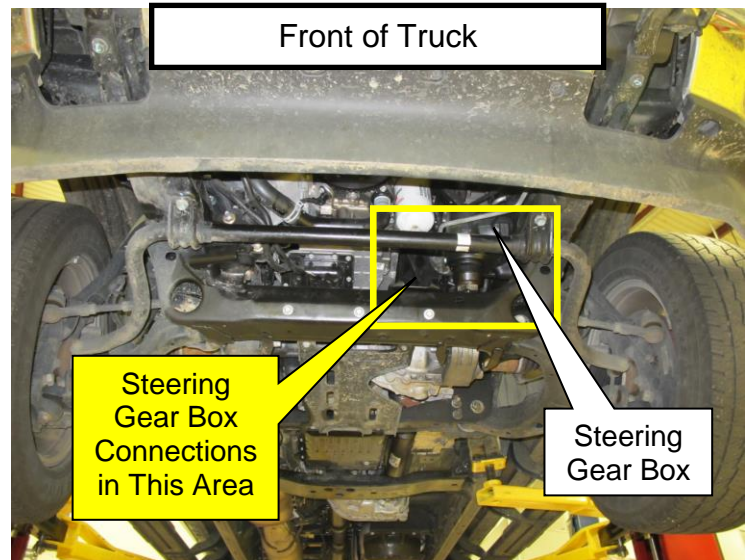
Figure 1

1. Locate the power steering box connections for the Power Steering Hose Assembly (Pressure) and Power Steering Hose Assembly (Return) (Figure 1, 2, 3).

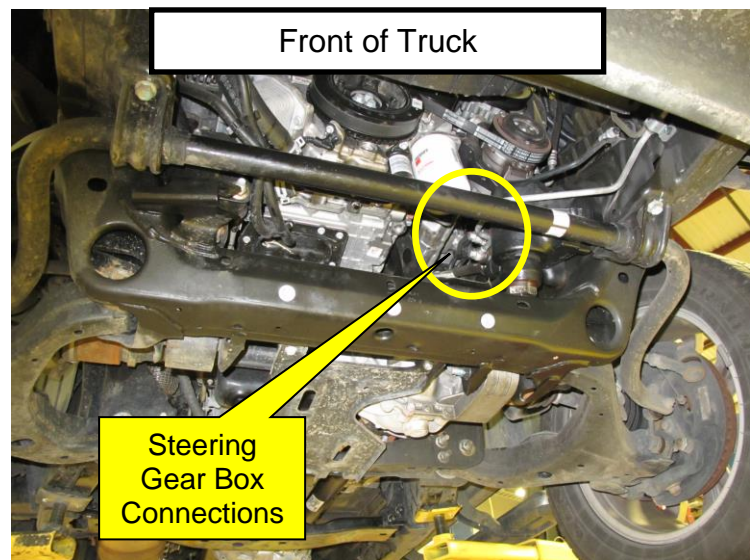
Figure 2

2. Inspect for **LEAKS** between the Steering Gear Box and Power Steering Hose Assembly (Pressure) and Power Steering Hose Assembly (Return) eye bolt connections (Figure 3).

- If **NO LEAK** found, inspection is complete, proceed to step 11 to install front under cover.
- If **LEAK** found, proceed to step 3.
