CAMPAIGN BULLETIN

Automatic Transmission Dealer Inventory

Reference: PC566
Date: April 28, 2017

PC566 – TITAN XD (A61D, 4WD) MULTI-POINT INSPECTION

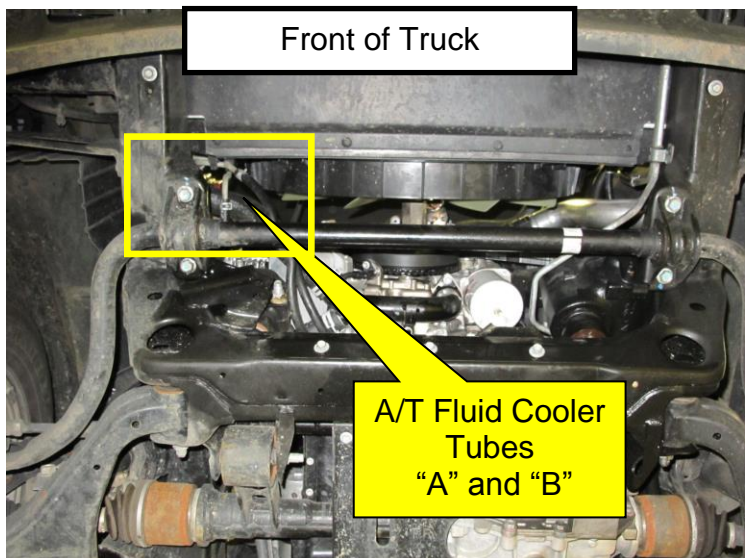
Figure 5

5. Locate the A/T fluid cooler hose "A" and "B" connections at the front passenger side of the truck (Figure 5).

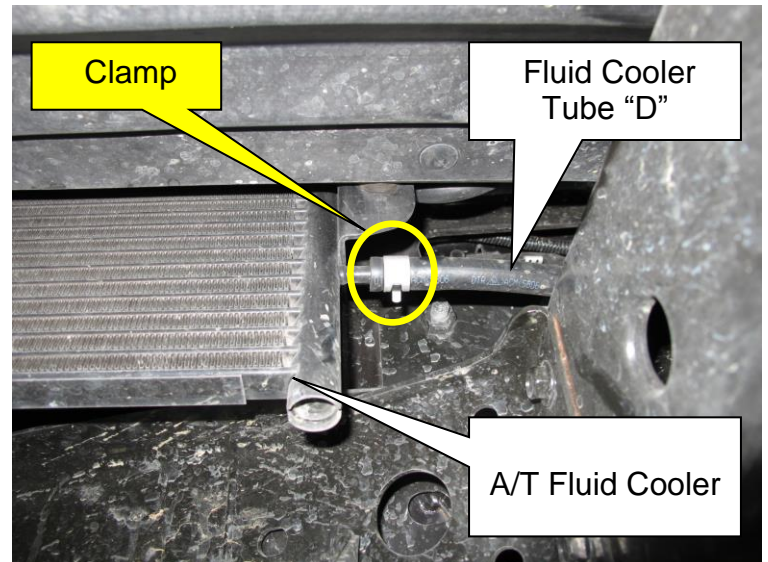
Figure 12

10. Locate the clamp connecting the A/T fluid cooler and fluid cooler tube "D". (Figure 12)

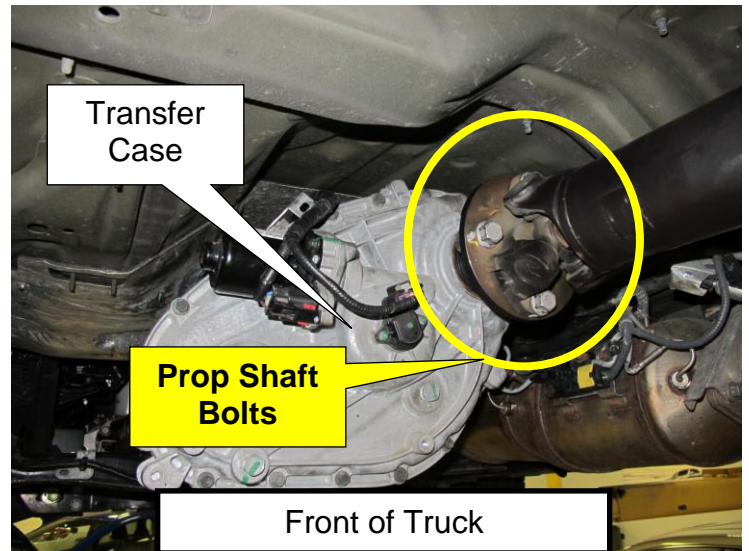
Figure 1

1. Locate the (4) rear prop shaft bolts at the transfer case (Figure 1).

2. Using a suitable tool apply LIGHT to MODERATE force to one of the 19MM nuts, repeat on the other nuts (Figure 2).
 - A. If **any** of the nuts move (NOT the prop shaft) **replace all 4** of the rear prop shaft bolts and nuts, (see Parts Information below).
 - Torque NEW Rear Prop Shaft bolts and nuts:
105N·m (77 ft-lb)
 - B. If nuts do not move (are tight) go to inspection 3.

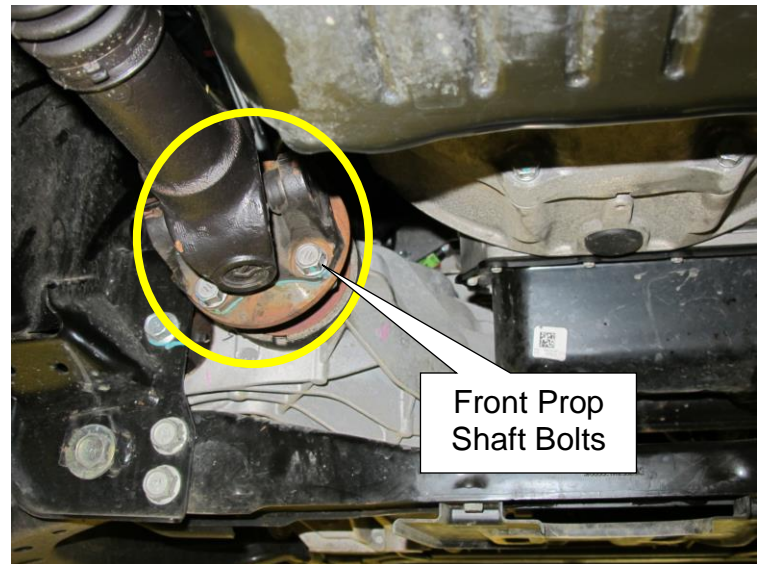
Figure 1

1. Locate the (4) front prop shaft bolts at the front differential (Figure 1).

2. Place a 17MM box end wrench on one of the inside nuts, while holding the Prop Shaft in place apply LIGHT to MODERATE force, repeat on the other bolts. (Figure 2):
 - A. If **any** of the nuts move (NOT the prop shaft) **replace all 4** of the front prop shaft bolts and nuts, (see Parts Information below).
 - Torque NEW Front Prop Shaft bolts and nuts:
80N·m (59 ft-lb)
 - B. If nuts do not move (are tight) go to Inspection 4.
3. Once Inspection is complete and all bolts have been checked for torque and/or replaced, move to Inspection 4.

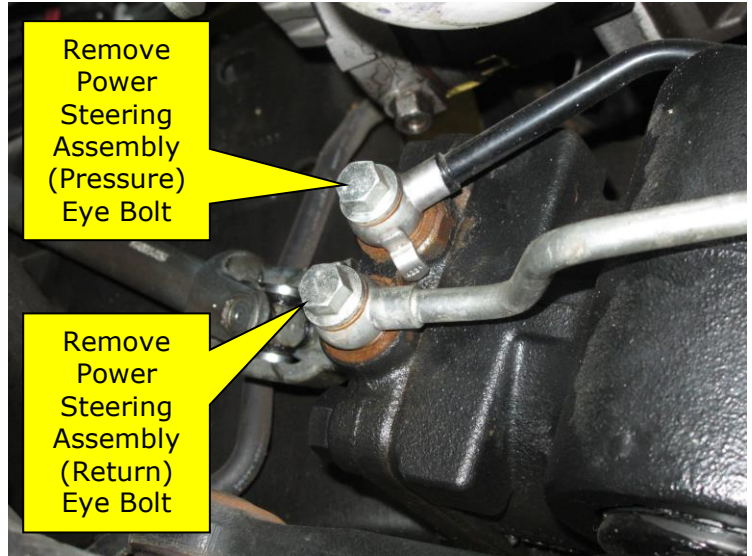
Figure 7

6. Remove Power Steering Hose Assembly (**Pressure & Return**) eye bolts (Figure 7).

- Remove old copper sealing washers and discard.
- Inspect and clean any debris from copper sealing washer mating surfaces.
