GROUP ELE	MODEL 2016MY Optima (JFa)
	NUMBER 130	DATE March 2017
<b>TECHNICAL SERVICE BULLETIN</b>		
<b>SUBJECT: SERVICE ACTION: ANTENNA INSPECTION AND/OR REPLACEMENT (SA272)</b>

## ANTENNA INSPECTION AND/OR REPLACEMENT (SA272)

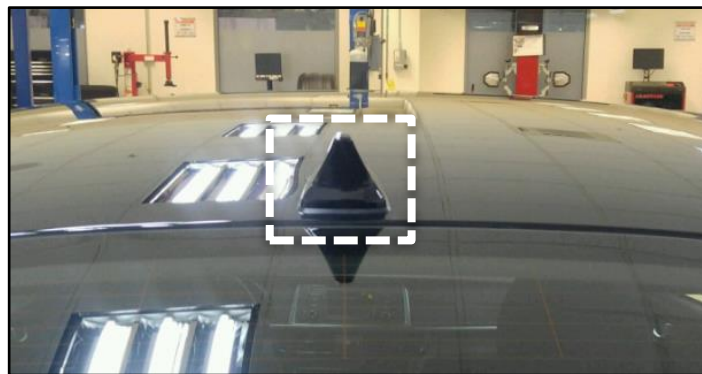
This bulletin provides the procedure to inspect and/or replace the antenna assembly on some 2016MY Optima (JFa) vehicles, produced from September 28, 2015 to June 1, 2016, which may experience an antenna cover separation/loss or looseness. Follow the procedure outlined in this bulletin to inspect and/or replace the antenna assembly. Before conducting the procedure, verify that the vehicle is included in the list of affected VINs.

1. With medium force, push the antenna from side to side to verify that the antenna cap is not broken. If a cracking noise is heard or if the cap comes loose, replacement of the antenna assembly is necessary. If cap is found to be structurally sound, no further action is required.
