## Technical product information

| <b>Topic</b> | Luggage compartment lid power open function fails using key fob |

### Continental GT Convertible

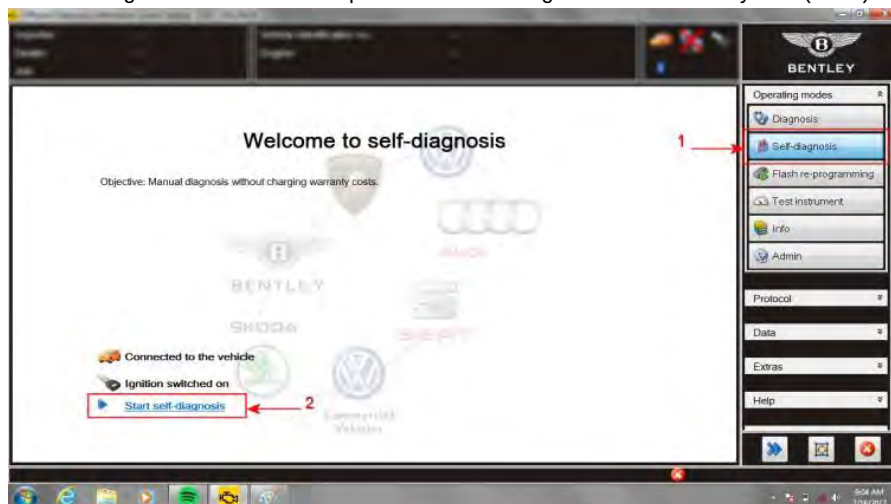
Figure 1

Boot lid control unit software error. Software 0804 may not always trigger a power open operation when initiated via the remote control key luggage compartment lid button (see Figure 1)

1. Verify the failure mode - 'Boot lid will not power open using remote control on key fob'
2. Check boot lid control unit software - (Address 006D Deck Lid Control Unit)
  - Ensure a suitable battery charger is correctly connected to the vehicle electrical system for the duration of this procedure
  - Switch on the ignition using the ignition key
  - Connect the Bentley approved diagnostic tool to the vehicle On Board Diagnostic (OBD) socket
  - From the diagnostic tool main desktop select Off Board Diagnostic Information System (ODIS)
