**HYUNDAI**NEW THINKING.
NEW POSSIBILITIES.**Technical Service Bulletin**GROUP
CAMPAIGNNUMBER
17-01-009-1DATE
**FEBRUARY
2017**MODEL(S)
**SANTA FE SPORT (AN)
SANTA FE (NC)****SUBJECT:****SANTA FE SPORT (AN), SANTA FE (NC)
REAR WHEEL SPEED SENSOR (SERVICE CAMPAIGN 949)*****THIS TSB SUPERSEDES 17-01-009 TO CLARIFY THE CONDITIONS FOR WSS COVER REPLACEMENT.*****★ IMPORTANT******* Dealer Stock and Retail Vehicles *****

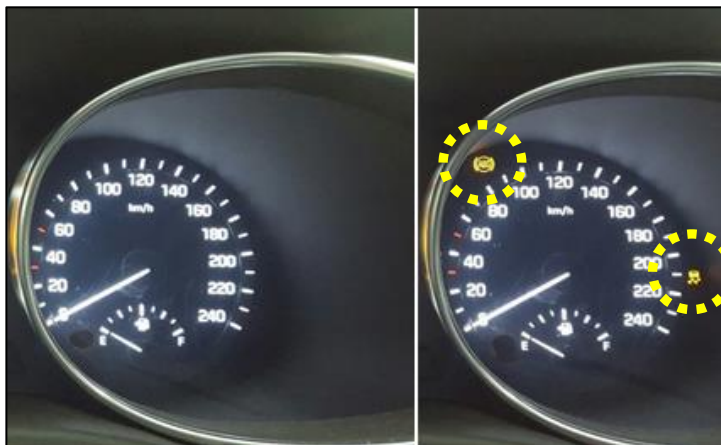
1. Start engine and wait a moment for the cluster lights to extinguish.
2. Check for the following two conditions:
 - 1) ABS/ESC warning lamp remains illuminated after engine start.
 - 2) DTC(s) from the “DTC Chart” below are present (history or current status).

If the ABS/ESC warning lamp is illuminated, AND any of the DTCs below are present, replace the WSS covers on BOTH SIDES of the vehicle.

If BOTH conditions are met, perform the “**Wheel Speed Sensor Cover Replacement**” service procedure starting on page 6.

If BOTH conditions are NOT met, perform the “**Silicone Application**” service procedure, below.
