HYUNDAI NEW THINKING. NEW POSSIBILITIES. Technical Service Bulletin	GROUP CAMPAIGN	NUMBER 17-01-010-1
	DATE FEBRUARY 2017	MODEL(S) Santa Fe (NC) Tucson (TL)
SUBJECT: ELECTRONIC STABILITY CONTROL (ESC) MODULE LOT # INSPECTION AND REPAIR (SERVICE CAMPAIGN T1J)

This TSB supersedes 17-01-010 to clarify the tool type must be Torx Plus.

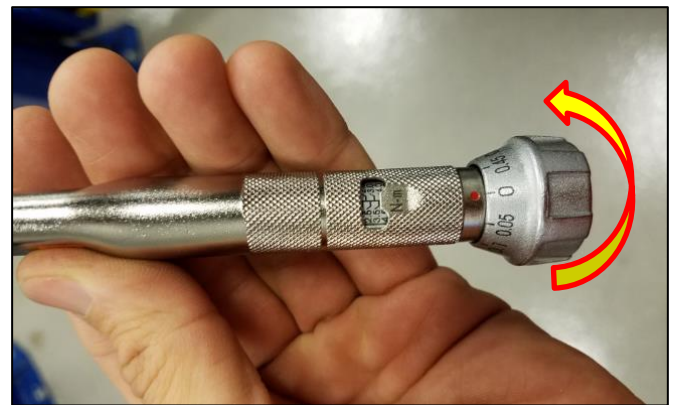
Upon removal, inspect the bolts for damage:

- If the bolt heads are damaged, replace the HECU continue to step 19.
- If the bolt heads are not damaged, replace the bolts with new ones and reassemble the vehicle in reverse order of removal to complete the service procedure. Use labor operation code **60C117R3**.

If new bolts are needed, use a small inch-lb torque wrench to install and torque the bolts to spec. 27.6 ~ 33.6 inch-lb.

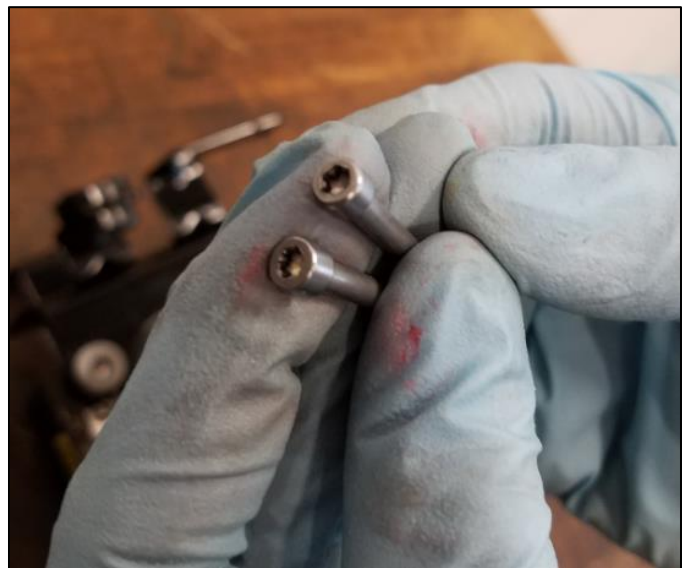
3. Upon removal, inspect the bolts for damage:

- If the bolt heads are damaged, replace the HECU continue to step 4.
- If the bolt heads are not damaged, replace the bolts with new ones to complete the service procedure. Use labor operation code **60C117R1**.

If new bolts are needed, use a small inch-lb torque wrench to install and torque the bolts to spec. 27.6 ~ 33.6 inch-lb.
