**HYUNDAI**NEW THINKING.
NEW POSSIBILITIES.**Technical Service Bulletin**GROUP
CAMPAIGNNUMBER
17-01-009-2DATE
MARCH 2017MODEL(S)
**SANTA FE SPORT (AN)
SANTA FE (NC)****SUBJECT:****SANTA FE SPORT (AN), SANTA FE (NC)
REAR WHEEL SPEED SENSOR (SERVICE CAMPAIGN 949)*****THIS TSB SUPERSEDES 17-01-009-1 TO REVISE THE NUMBER OF SPRAY NOZZLES AND STRAWS THAT ARE INCLUDED WITH EACH SILICONE SPRAY PART NUMBER.*****★ IMPORTANT******* Dealer Stock and Retail Vehicles *****

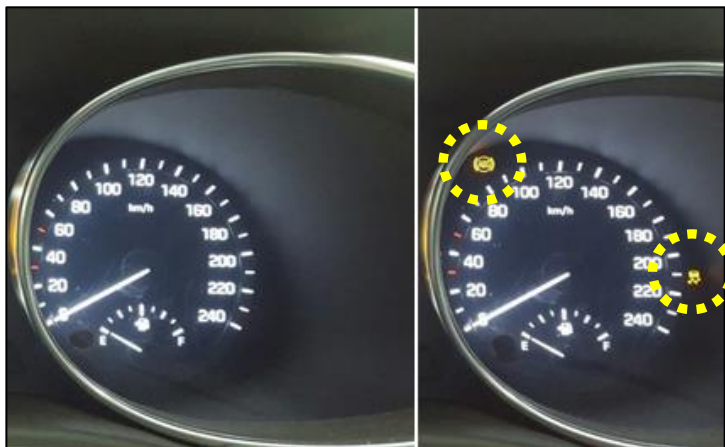
1. Start engine and wait a moment for the cluster lights to extinguish.
2. Check for the following two conditions:
 - 1) ABS/ESC warning lamp remains illuminated after engine start.
 - 2) DTC(s) from the “DTC Chart” below are present (history or current status).

DTC Chart	
If any of these are present (history or current), perform “Wheel Speed Sensor Cover Replacement.”	
Rear LH	Rear RH
C1206 – LH Open/Short	C1209 - RH Open/Short
C1207 – LH Range/Performance/Intermittent	C1210 - RH Range/Performance/Intermittent
C1208 – LH Invalid/No Signal	C1211 - RH Invalid/No Signal

If BOTH conditions are met, perform the “**Wheel Speed Sensor Cover Replacement**” service procedure starting on page 6.

If BOTH conditions are NOT met, perform the “**Silicone Application**” service procedure, below.

If the ABS/ESC warning lamp is illuminated, AND any of the DTCs below are present, replace the WSS covers on BOTH SIDES of the vehicle.
