Technical Service Bulletin

Mazda North American Operations
Irvine, CA 92618-2922

Subject: KNOCKING / SQUEAKING NOISE FROM FRONT SHOCK ABSORBER, CREAKING NOISE FROM FRONT LOWER ARM BUSHING	Bulletin No.: 02-003/17
	Last Issued: 03/02/2017

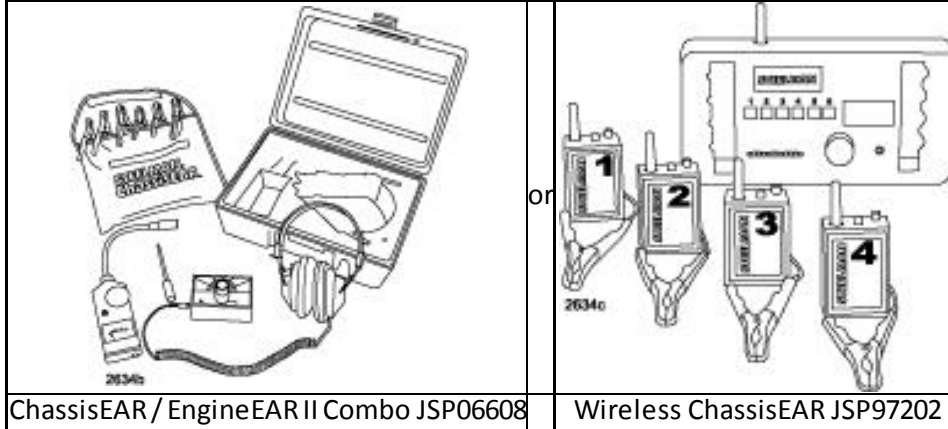
1. Use Special Service Tool (SST) ChassisEAR / EngineEAR II Combo JSP06608 or Wireless ChassisEAR JSP97202 to confirm noise is coming from the front suspension when driving over bumps and/or turning the steering wheel while the vehicle is stopped:
