Technical Service Bulletin

Mazda North American Operations
Irvine, CA 92618-2922

Subject: ALUMINUM WHEEL PAINT DAMAGE (BLACK SPOT, WHITE SPOT, FLAKING, DISCOLORED, BLACKENED)	Bulletin No.: 02-002/17
	Last Issued: 03/09/2017

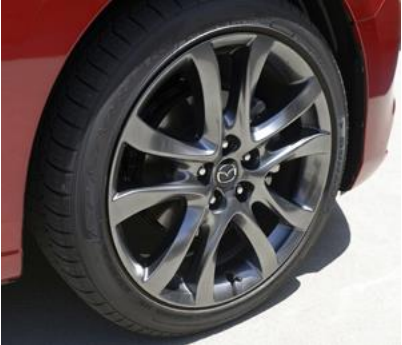
New Part Number	Old Part Number	Description	Qty.	Notes	Image
9965-20-7590	9965-12-7590	ALUMINUM WHEEL	1 - 4	Mazda6 19 inch alloy with dark silver finish

1. Verify customer concern.
2. Is the **aluminum alloy type** wheel concern caused by an outside influence?
 - No - Go to step 3.
 - Yes - This service bulletin does not apply.
3. Replace the affected aluminum wheel(s). Refer to MS3 online Workshop Manual WHEEL BALANCE ADJUSTMENT (ALUMINUM ALLOY WHEEL).
4. Verify repair.

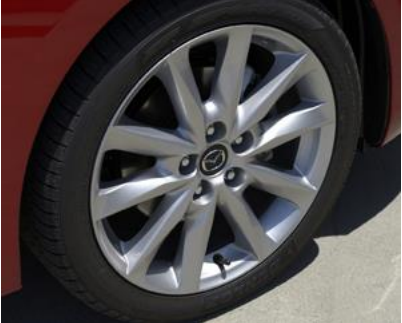
9965-59-7080	9965-29-7080 9965-46-7080	ALUMINUM WHEEL	1 - 4	Mazda3 Mexico only 18 inch alloy
