# Service Bulletin

**Subject:** Service Theft Deterrent System Message on DIC, No Start, DTC B2955

Brand:	Model:	Model Year:		VIN:		Engine:	Transmission:
		from	to	from	to		
Chevrolet	Trax	2017	2017			All	All

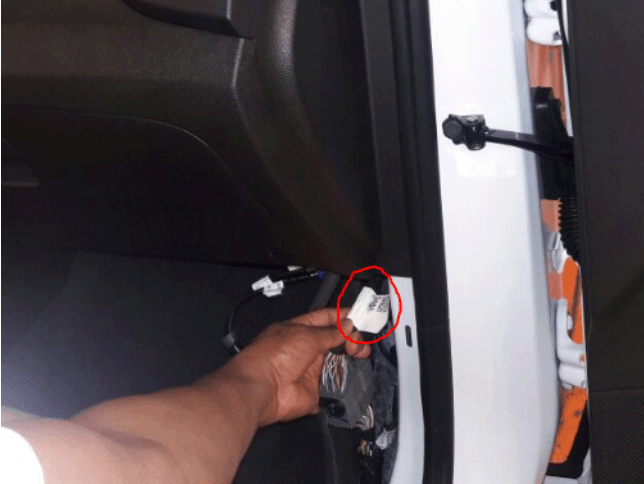
2. Visually inspect the julian date on the IP harness.

**Note:** The julian date goes as follows: XXAABBB (AA = Year (Example shown shows 2016) BBB = Day (Example shown shows August 9th 2016))

1. Remove the passenger floor auxiliary mat lower retainer. Refer to *Floor Auxiliary Mat Lower Retainer Replacement (Chevrolet)* in SI.
