Service Bulletin

Subject: Modified Headlamp Aim Procedure for Horizontal Aim Adjuster Difficult or Inoperative

Brand:	Model:	Model Year:		VIN:		Engine:	Transmission:
		from	to	from	to		
Cadillac	ATS	2013	2017			All	All

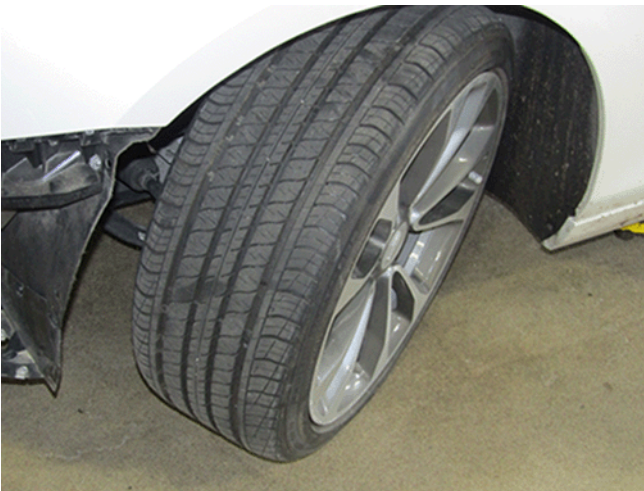
Note: The front fascia is shown removed in several of the graphics for illustration purposes only. It is NOT necessary to remove the fascia to complete this aiming procedure.

1. Position the vehicle on a level surface in preparation for headlamp aiming. Refer to the appropriate *Headlamp Aiming* procedure in SI.

2. Turn the steering wheel to position front of tire as far outboard as possible on the affected side.
