**HYUNDAI**NEW THINKING.
NEW POSSIBILITIES.**Technical Service Bulletin**

17-01-053

SANTA FE (NC)**SUBJECT:**SANTA FE (NC) FRONT CABIN WATER INTRUSION
(SERVICE CAMPAIGN T2G)*** IMPORTANT******* Dealer Stock and Retail Vehicles *****

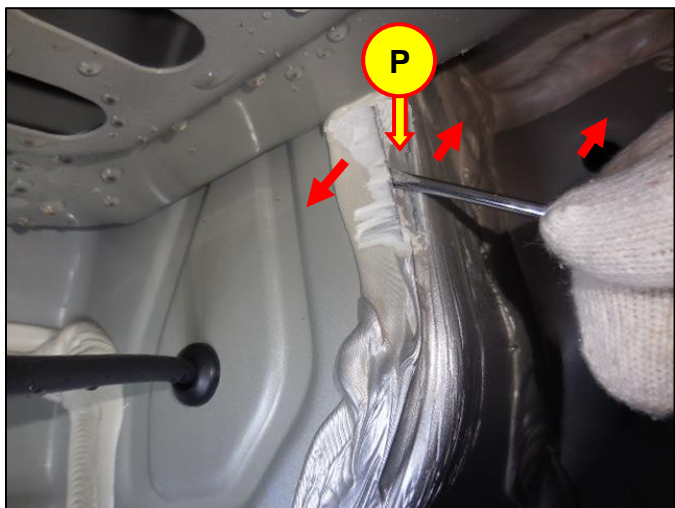
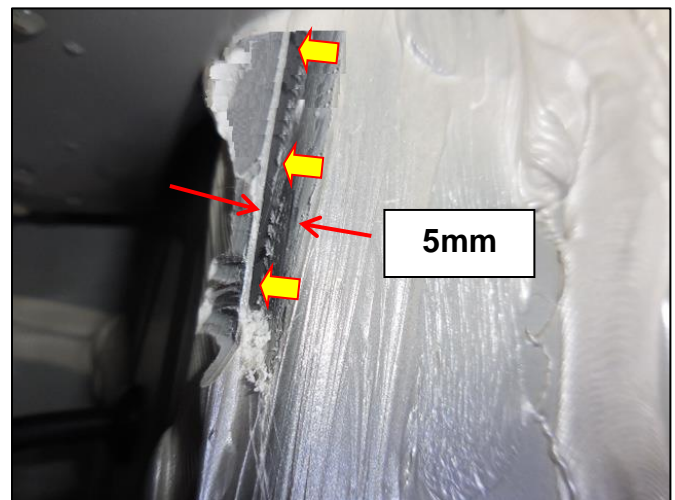
Excessive gaps may become harder to seal and may result in water intrusion into the cabin.

8. Insert the flat screwdriver (P) to pry open about 5mm of the panel opening for seam sealer application.

Do not pry open the panels more than 5mm.
