**Countries:** CANADA, UNITED STATES **Document ID:** IK1201325  
**Availability:** ISIS, Bus ISIS, NotSIR **Revision:** 36  
**Major System:** ENGINES **Created:** 3/4/2016  
**Current Language:** English **Last Modified:** 4/28/2017  
**Other Languages:** NONE **Author:** Mark Ehlers  
**Viewed:** 14328

**Title:** CPA BEAM RCT+, CCP and BBT tips (used with new CPA PressurePlus tool)

**Applies To:** MaxxForce 7, DT, 9, 10, 13, N9, N10, N13

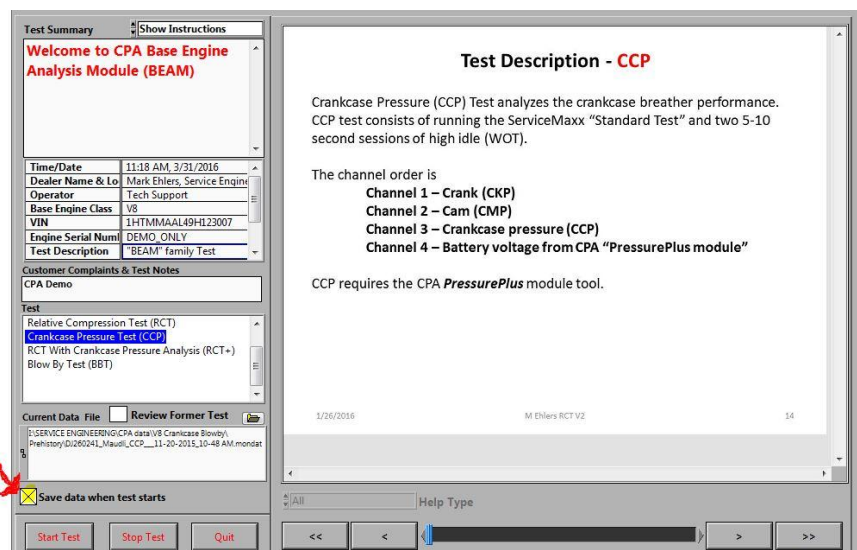
- CCP (Crankcase Pressure test- MaxxForce 7 ONLY) uses the PressurePlus module and the CPA box to measure crankcase pressure instead of a water manometer or magnahelic gauge. The crankcase breather is functioning normally for this test.
- If the engine cannot run the Navistar Engine Diagnostics™ Standard test (as requested in BBT and CCP test) then do the following:
  - Check this box

- When CPA requests the Navistar Engine Diagnostics™ test, hold the throttle wide open (WOT) for 5 seconds (fan OFF)
  - Idle for 4 seconds
  - WOT for 5 seconds (fan OFF)
  - Press "Stop Test"
  - CPA will process the test and create the Results Graph
- Crankcase Leak Detected Message
    - This message can be caused by several factors. Click [HERE](#) for more explanations.
    - If after performing RCT+ the "Crankcase Leak Detected" message appears the "Test Data" screen may look like the screen below
