MODEL  
2016MY  
Sorento (UMa)

NUMBER  
125 (Rev 2, 6/13/2017)

## TECHNICAL SERVICE BULLETIN

SUBJECT: PANORAMIC SUNROOF SLOW TO CLOSE AND/OR  
ABNORMAL NOISE WHEN CLOSING

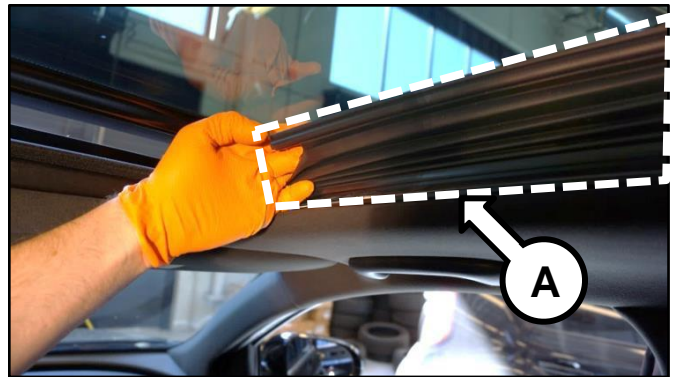
2. With the panoramic sunroof roller blind retracted, carefully remove the accordion covers (A) on the right and left side.

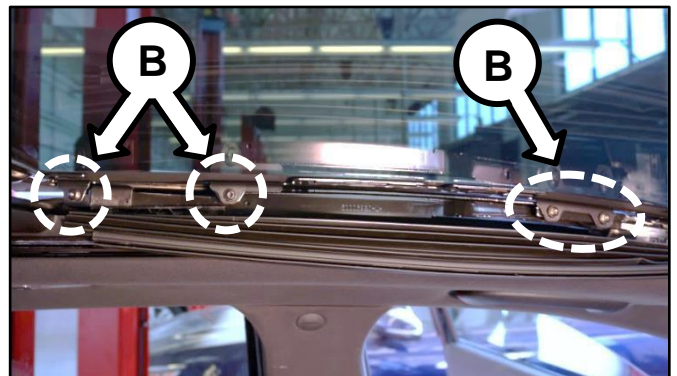
3. Using a T25 Torx® socket, remove the four (4) screws (B) on the right and left side.

Use caution not to scratch or damage the glass during removal of the screws.

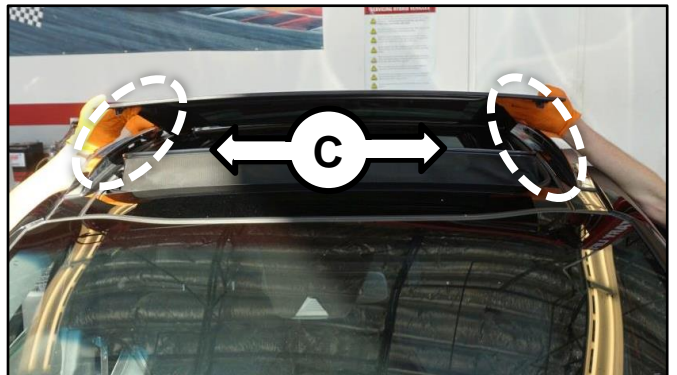
4. With the assistance of another person, remove the panoramic sunroof glass by sliding the glass towards the front of the vehicle until the sliders are out of the tracks (C).

Use caution not to scratch or damage, or break the glass during removal.

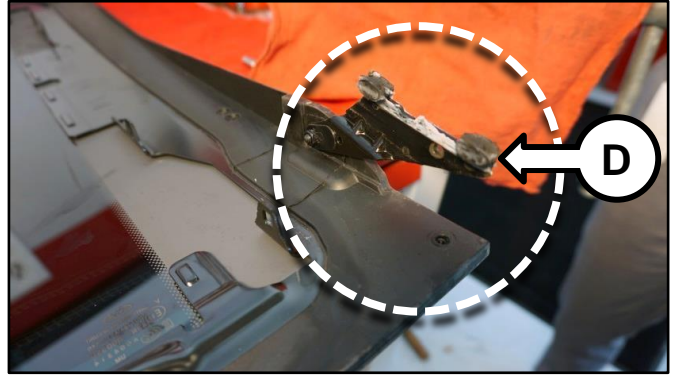
5. Lay the glass on a soft, flat, protected surface with the tilt levers (D) facing up.

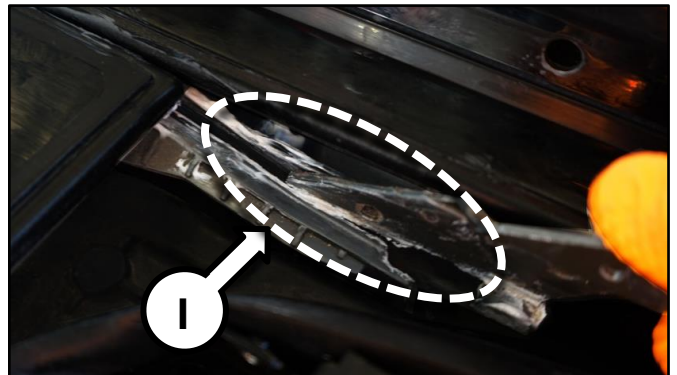
10. With the assistance of another person, carefully reinstall the panoramic sunroof glass by inserting the tilt levers into the guide rail (I).

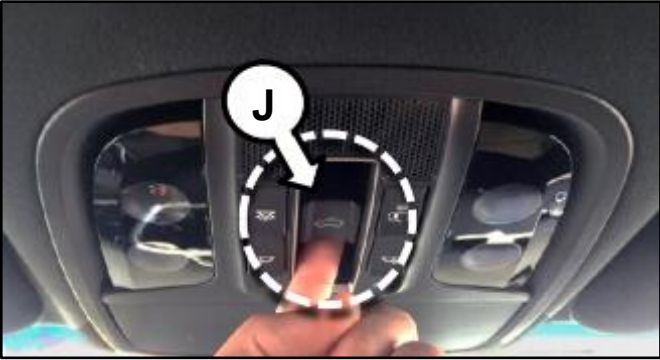
- 2. Press and hold the CLOSE button (J) for 10-15 seconds until the sunroof fully closes then retracts slightly. The sunroof operates as follows:
