LTB00827NAS7

TECHNICAL BULLETIN

Ticking Noise From 'B' Pillar Area

MODEL:	MODEL YEAR:	VIN:	ASSEMBLY PLANT:
Discovery Sport (LC)	2015 Onwards	500429 Onwards	Halewood

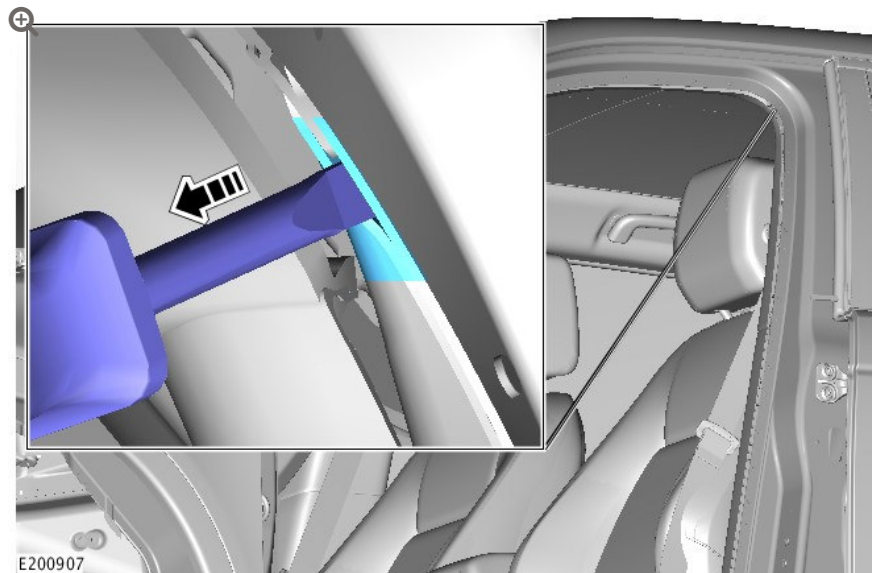
- This will cause the inner 'B' pillar panel and the cant rail to separate.
 - This will eliminate the noise from this area.

Remove the suitable chisel.
