ATTENTION: This Technical Service Bulletin was issued by Southeast Toyota Distributors, LLC.

Category: Audio/Visual/Telematics Section: Navigation/Multi Info Display

SET Advent Navigation System Hard Reset Procedure

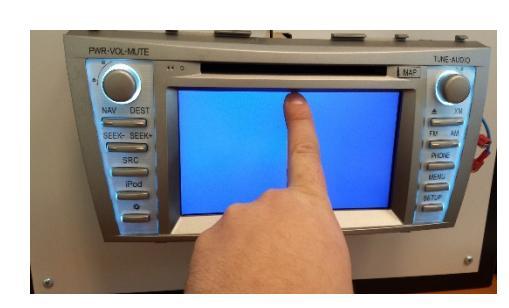
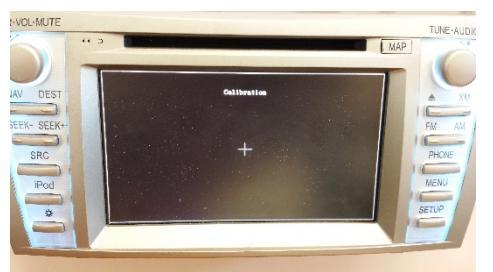
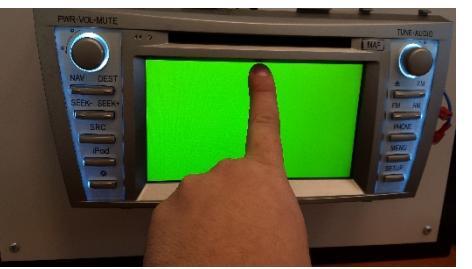
8. Touch Calibration Screen is displayed. Follow the calibration prompts by placing your finger in the center of the cross hairs.

NOTE: If the curser moves too rapidly to touch, digitizer for radio touch screen has failed. Replacement radio needed.

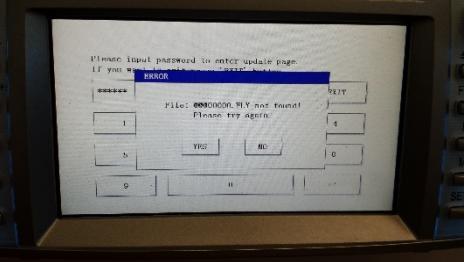
- If you get an error message
 "@@@00000.FLY Not Found! Please try again" press the NO button, then press
 EXIT and confirm by selecting YES.
- The error message indicates new software is required. To request updated software SD card, Contact Southeast Toyota Accessory Hotline (888)851-2722, Press prompt 3 for Technical Assistance.

During the Hard Reset process the radio will flash status bars across the screen indicating progress. Let it run through the entire process and DO NOT shut the radio or vehicle off during this process as damage may occur to the radio. This process should take about 5 minutes.

Once complete, the radio will reboot and start up normally.
