DAS (Display Audio Smartphone Link) Part Number Inspection

DATE: June 2, 2017

AFFECTED VEHICLES: Certain 2017 Lancer SAM & 2017 Outlander Sport SAM

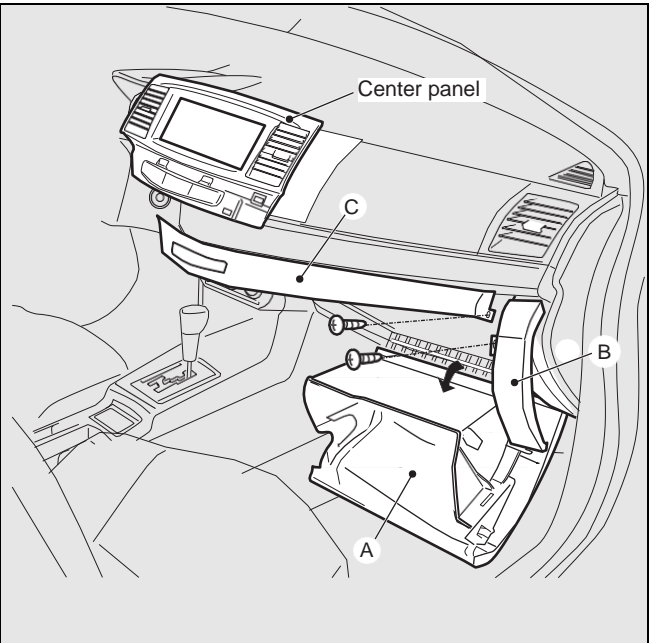
2. Remove the vehicle parts in the order A, B, C as indicated.

- Detach the center panel, but **DO NOT** disconnect the connector.
- Hold the center panel in place while conducting the inspection.

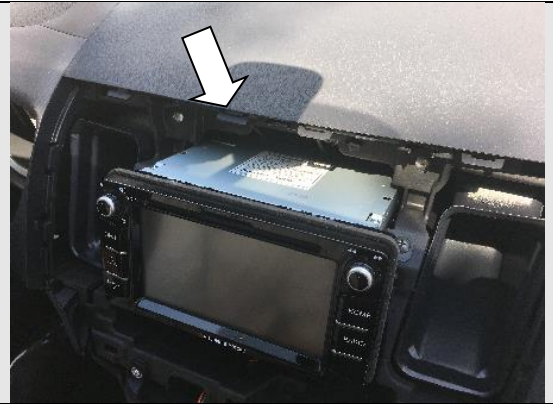
3. Locate the DAS audio label part number.

4. The 2017MY Lancer SAM correct part number is MZ360599EX.

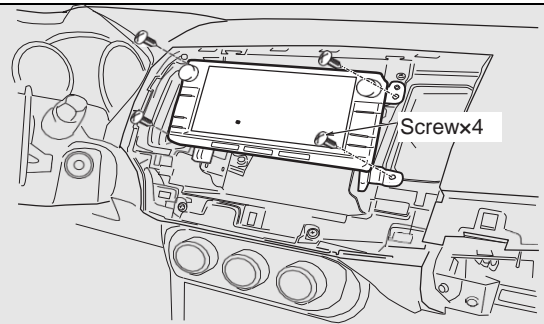
- Disconnect the negative battery terminal.
- Disconnect the audio panel.
- Remove the 4 audio bracket screws and pull radio out just far enough to access the entire parts label.

- Cross out the old part number and write in the correct part number (**MZ360599EX**) with a Sharpie ultra fine point permanent marker.

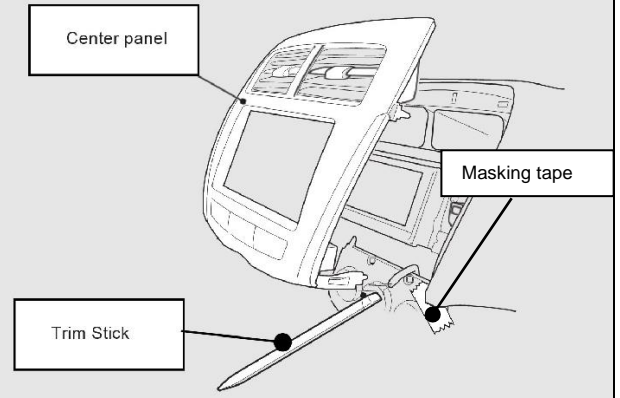
2. Detach the center panel.
(DO NOT remove it.)

- Apply masking tape at the RH upper corner of the HVAC control panel to prevent scuffing.
- Insert trim stick underneath audio panel slot to pry panel loose.
- Detach the center panel dash but **DO NOT** disconnect the connector.
- Hold the center panel in place while conducting the inspection.

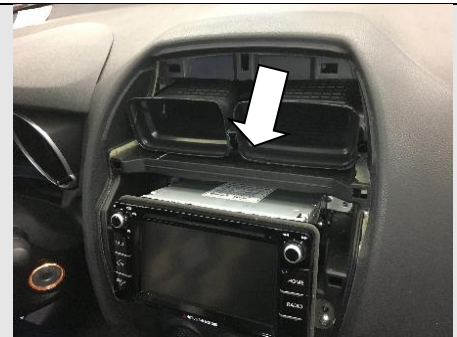
3. Locate the DAS audio label part number.

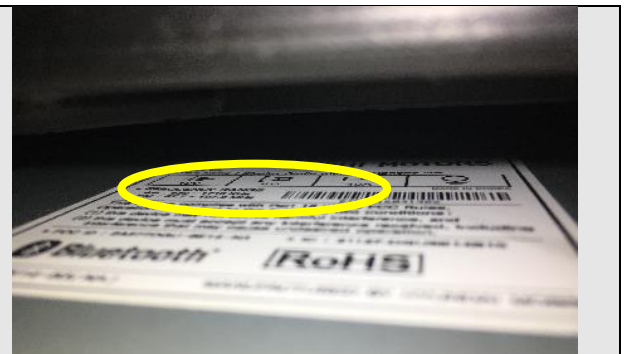
4. The 2017MY Outlander Sport SAM DAS part number is located at the top left corner of the affixed label.

5. The 2017MY Outlander Sport correct part number is MZ360569EX.

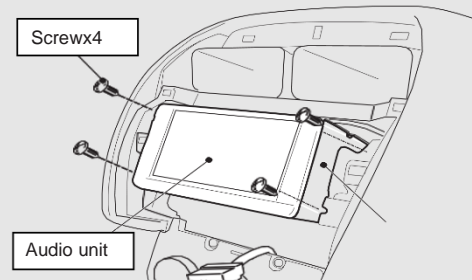
- Disconnect the negative battery terminal.
- Disconnect the audio panel.
- Remove the 4 audio bracket screws and pull radio out just far enough to access the entire parts label.

- Cross out the old part number and write in the correct part number (**MZ360569EX**) with a Sharpie ultra fine point permanent marker.
