Q649 UPS8316-5BNAS1

TECHNICAL BULLETIN

501-20A

Update Prior to Sale: Second Row Outer Seatbelt Pre-Tensioner

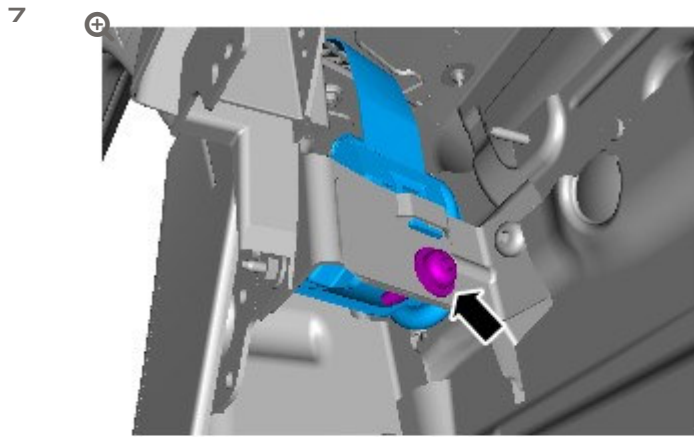
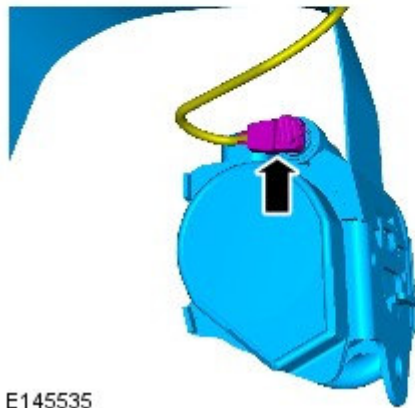
Remove the second row seating outer left seatbelt retractor.

- Torque: **45 Nm**

- A new retractor bolt (LR084136) must be fitted.
- Any vehicle that did not pass the Inspection Procedure and is awaiting a new component(s) may be reassembled with a new bolt(s) and the repairs claimed as though it did pass the Inspection Procedure

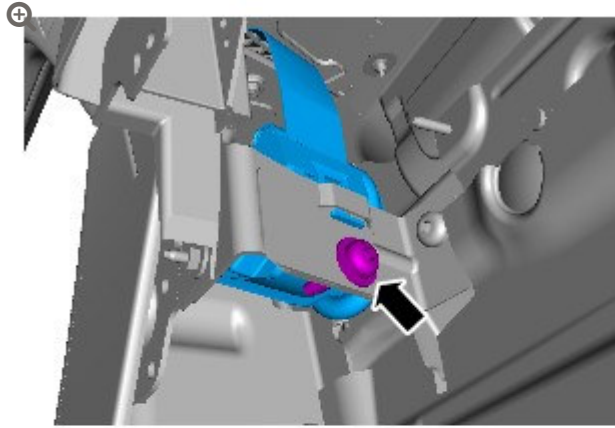
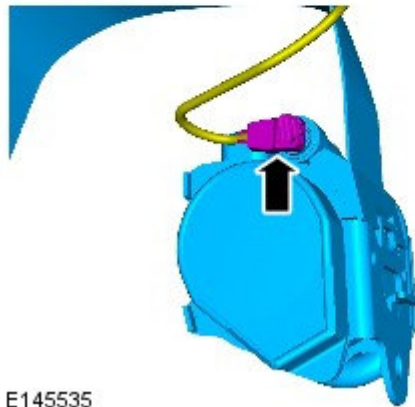
E145535

Remove the second row seating outer right seatbelt retractor.

- Second row seating outer left seatbelt retractor and label shown; second row seating outer right seatbelt retractor and label similar.
- A new retractor bolt (LR084136) must be fitted.
- Any vehicle that did not pass the Inspection Procedure and is awaiting a new component(s) may be reassembled with a new bolt(s) and the repairs claimed as though it did pass the Inspection Procedure
