Vantage Mobility International

Document Number: TS-WI-0225

ASSEMBLY AREA	Tech Service
MODEL	2017 Pacifica RU Touring and Touring L

It has been determined by VMI that converted Chrysler Pacifica's **prior to July 5 2017**, may have not been wired correctly to accommodate the interchangeable seat option. This is in evidence **ONLY** when the driver's seat is powered and the passenger front seat is manual. This document provides detailed instructions for Technicians to add the necessary power and ground wire for interchangeable seating. This document also includes instructions on how to provide this circuit with a more secure ground. **If your van has power seats on both driver and passenger you may still want to update the ground.**

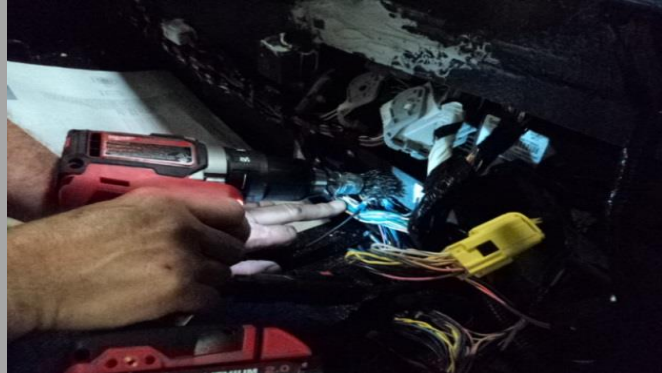
13. The back of the connector is numbered. Insert the black wire provided in the kit, which is the ground, into position #15.
