HYUNDAI NEW THINKING. NEW POSSIBILITIES. Technical Service Bulletin	GROUP CAMPAIGN	NUMBER 17-01-010
	DATE JANUARY 2017	MODEL(S) Santa Fe (NC) Tucson (TL)
SUBJECT: ELECTRONIC STABILITY CONTROL (ESC) MODULE LOT # INSPECTION AND REPAIR (SERVICE CAMPAIGN T1J)

This TSB supersedes 16-01-065 to include repair procedures for vehicles with affected lot number ESC modules.

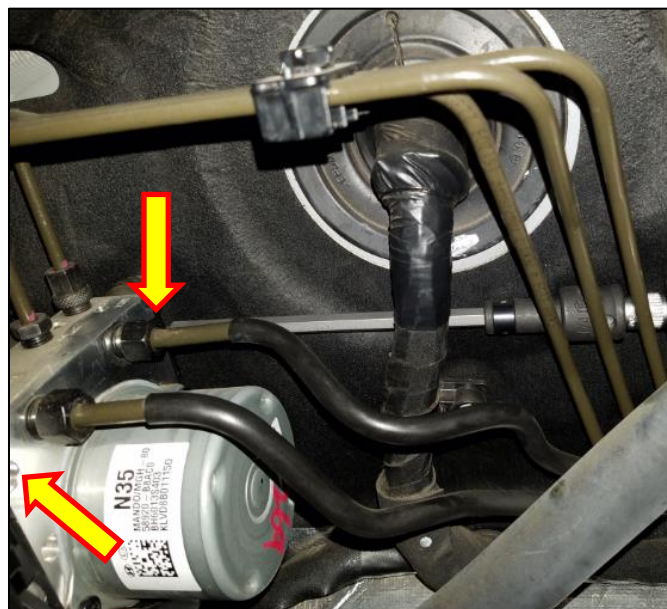
Upon removal, inspect the bolts for damage:

- If the bolt heads are damaged, replace the HECU continue to step 19.
- If the bolt heads are not damaged, replace the bolts with new ones and reassemble the vehicle in reverse order of removal to complete the service procedure. Use labor operation code **60C117R3**.

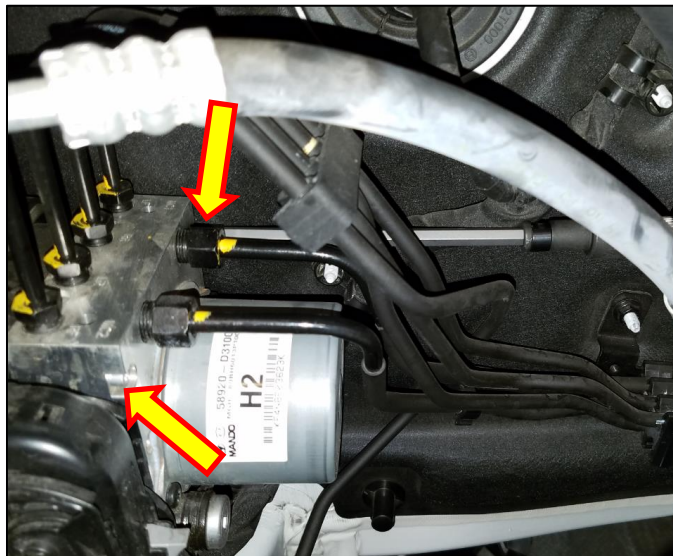
3. Upon removal, inspect the bolts for damage:

- If the bolt heads are damaged, replace the HECU continue to step 4.
- If the bolt heads are not damaged, replace the bolts with new ones to complete the service procedure. Use labor operation code **60C117R1**.
