HYUNDAI NEW THINKING. NEW POSSIBILITIES.	GROUP CAMPAIGN	NUMBER 17-01-002
	DATE JANUARY 2017	MODEL(S) SANTA FE SPORT (AN)
Technical Service Bulletin		
SUBJECT: FUEL FILLER CAP REPLACEMENT (SERVICE CAMPAIGN T1Q)

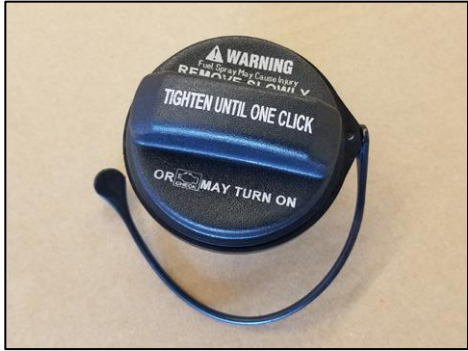
Some 2017MY Santa Fe Sport (AN) vehicles may have the condition where the fuel filler cap seal may not provide proper sealing and trigger the Check Engine Light with the following DTC(s).

- P0442: Evaporative Emission System - Leak detected (Small Leak)
- P0456: Evaporative Emission System - Leak detected (Very Small Leak)

This bulletin provides the procedure to replace the fuel filler cap to correct this condition.

Part Name	Part Number	Qty.	Figure
Fuel Filler Cap	31010-3L600	1
