<b>Subject:</b> <b>SECOND-ROW SEAT WALK-IN LEVER DOES NOT WORK</b>	<b>Bulletin No.:</b> 09-036/17
	<b>Last Issued:</b> 08/09/2017

2016-2017 CX-9 vehicles with VINs lower than JM3TC\*\*\*\*\*142166 (produced before May 22, 2017)

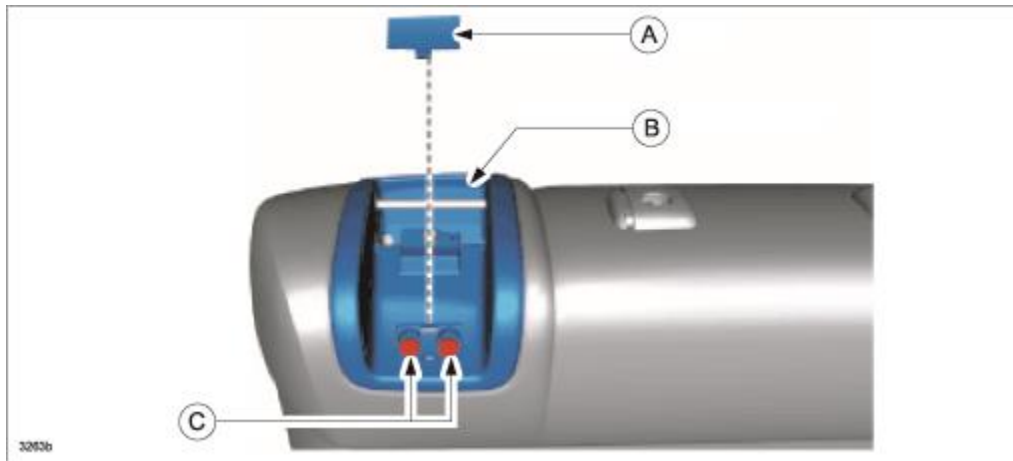
A	Cover
B	Walk-In Lever
C	Screws

1. Verify the customer concern.
2. Replace the walk-in lever with a modified one according to the "WALK-IN LEVER REMOVAL/INSTALLATION PROCEDURE" instructions below.
