Technical Service Bulletin

KNOCKING / SQUEAKING NOISE FROM FRONT SHOCK ABSORBER, CREAKING NOISE FROM FRONT LOWER ARM BUSHING Bulletin No.: 02-003/17

Last Issued: 08/29/2017

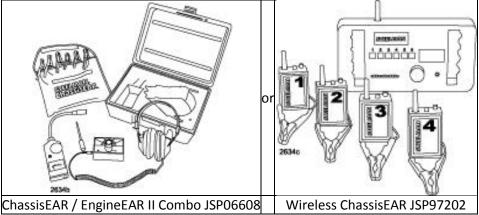
1. Use Special Service Tool (SST) ChassisEAR / EngineEAR II Combo JSP06608 or Wireless ChassisEAR JSP97202 to confirm noise is coming from the front suspension when driving over bumps and/or turning the steering wheel while the vehicle is stopped:

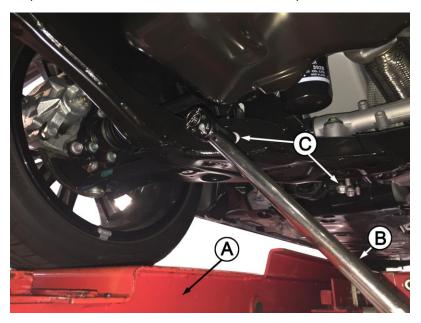
NOTE: For the joint sections with rubber bushings, raise the vehicle using a lift, and then temporarily tighten the installation bolts. Then raise the vehicle using a wheel alignment lift rack (A) or lower the vehicle to the ground (to load the suspension). Use a torque wrench (B) to tighten the bolts (C) to the specified tightening torque. The Mazda6 is shown below as an example.

5. Install the front lower arm (both sides) according to MGSS online instructions or the Workshop Manual (section 02-13 FRONT LOWER ARM REMOVAL/INSTALLATION).

- 6. Inspect the wheel alignment and adjust if necessary.
- 7. Verify repair.
