JTB00553NAS1

TECHNICAL BULLETIN

Roof Blind Does Not Open Correctly

MODEL:	MODEL YEAR:	VIN:	ASSEMBLY PLANT:
XE (X760)	2017	P00001-P21577	Castle Bromwich
XF (X260)	2016-2017	Y00001-Y41198	Castle Bromwich
F-PACE (X761)	2017 Onwards	045000-086391	Solihull

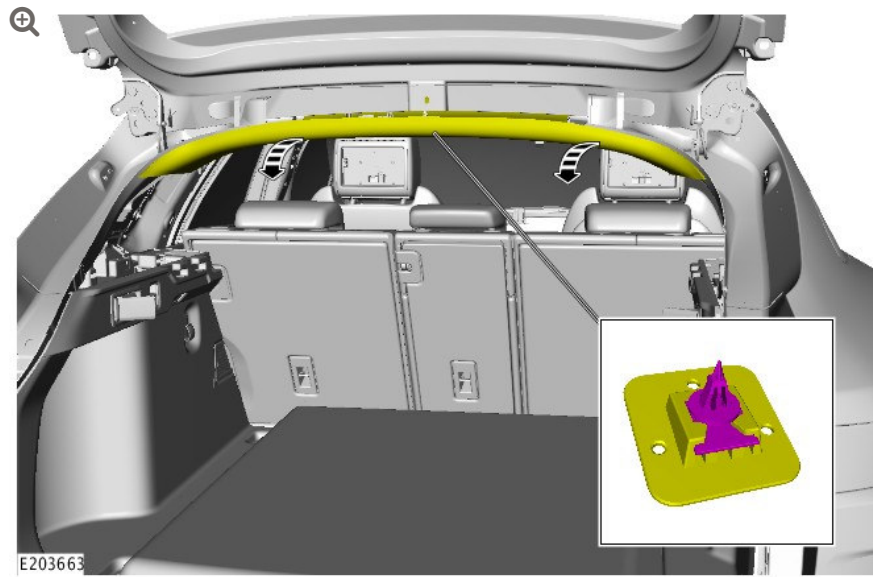
Lower the headlining to access the roof blind wiring harness.

This may be caused by a fault with the roof blind wiring harness.
