SIL 2-EP-16, Rev. B  
September, 2017  
Page 1 of 16

**SUBJECT:** Replacing BCA (Bias-Control Assembly) Cards Inside of the Dual Power Inverter Module 2 (DPIM2)

**MODELS AFFECTED:** H 40/50 EP™ System Equipped with DPIM2

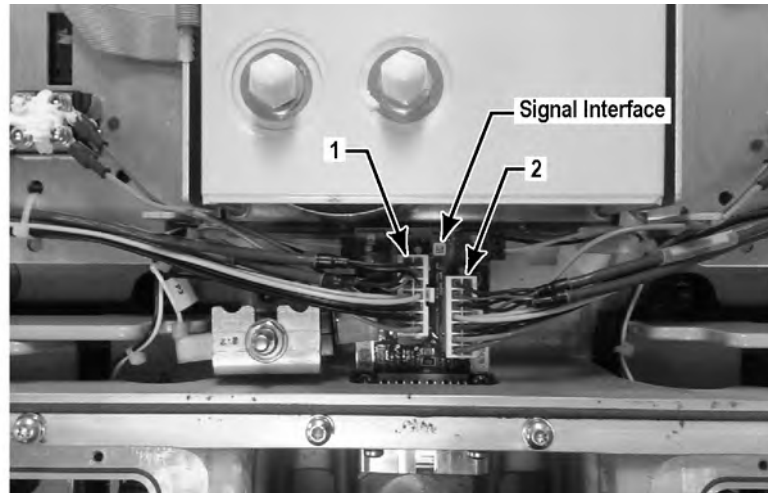
**Figure 5. Signal Interface Connectors**

Condition: Fuse (10-40A) for 12V DPIM power or fuse (10A) for 12V DPIM wakeup fails whenever the DPIM 24-way connector is plugged in.

3. Isolate each of the low voltage circuits of each inverter by removing the two (2) white connectors from the signal interface. Refer to Figure 5.

- a. Plug in the OEM 24-way connector with the two (2) internal harness connectors removed from the Signal Interface. If the 10A fuse fails again, the Signal Interface may need to be replaced.
- b. Plug the white A-Inverter connector into the Signal Interface and “Key On” the bus.
  - If the 10A fuse fails again, the issue is with the A-Inverter.
  - If the 10A fuse does NOT fail, connect the connector for the B-Inverter while leaving the white A-inverter connector mated and “Key On” the bus to determine if the B-Inverter is causing the 10A fuse failure.
4. After determining which inverter is causing the 10A fuse to fail, disconnect the three (3) ribbon cables going to the Gate Drives (refer to Figure 6).
