GROUP ENG	MODEL 2016-2017MY Optima (JF) 2017MY Sportage (QL)
	NUMBER 175	DATE August 2017

TECHNICAL SERVICE BULLETIN

SUBJECT: SERVICE ACTION: E-CVVT COVER INSPECTION
AND MOTOR PLUG REPLACEMENT (SA305)

P0010: 'A (Intake)' Camshaft Position Actuator Circuit (Bank 1)

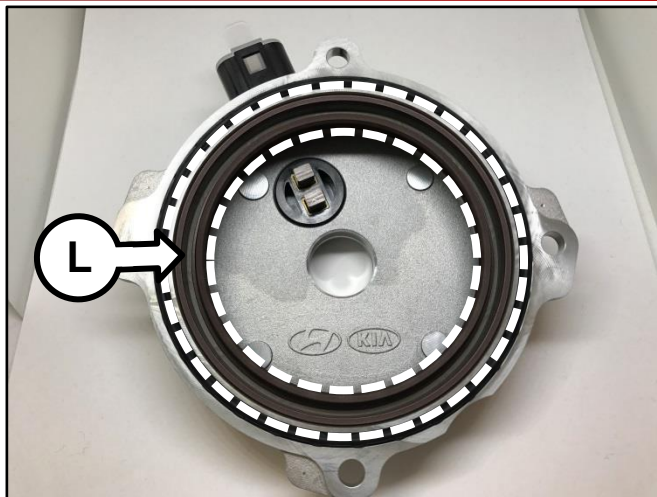
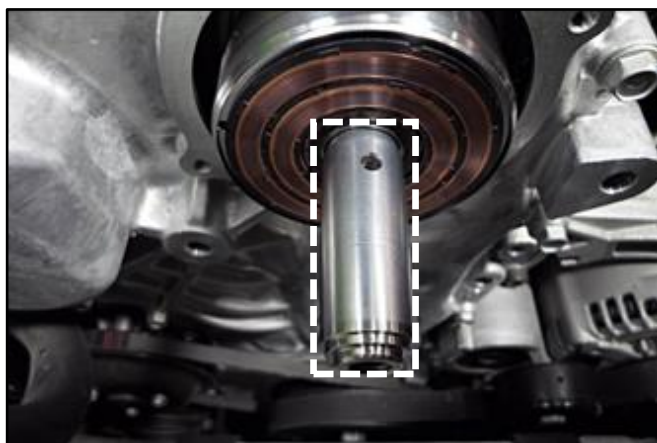
SST INSERTED INCORRECTLY

SST INSERTED CORRECTLY

- Apply oil to the oil seal lip (L) of the E-CVVT cover and install the SST "B" to the E-CVVT motor as shown.

When installing the cover, correctly insert the end of the SST to the motor shaft as shown below. Ensure that the SST hole faces towards the motor shaft.

Use caution not to fold the oil seal when installing the cover.
