GROUP <b>ENG</b>	MODEL <b>2016-2017MY Optima (JF, JFa), Sorento (UMa) 2017MY Sportage (QL)</b>
	NUMBER <b>175 (Rev 1, 09/20/2017)</b>	DATE <b>August 2017</b>
<b>TECHNICAL SERVICE BULLETIN</b>		
SUBJECT: <b>SERVICE ACTION: E-CVVT COVER INSPECTION AND MOTOR PLUG REPLACEMENT (SA305)</b>

This bulletin provides information regarding the inspection and/or replacement of the E-CVVT cover or O-ring and replacement of the motor plug on some 2016-2017MY Optima (JF, JFa), 2016-2017MY Sorento (UMa), and 2017MY Sportage (QL) vehicles, equipped with 2.4L GDI or 2.0T-GDI, which may exhibit a malfunction indicator light (MIL) ON with DTC P001000 and/or oil leakage in the E-CVVT motor plug of applicable vehicles. Follow the procedure outlined in this bulletin to inspect and/or replace the E-CVVT cover or O-ring and replace the motor plug to correct the concern. Before conducting the procedure, verify that the vehicle is included in the list of affected VINs.

## SERVICE ACTION: E-CVVT COVER INSPECTION AND MOTOR PLUG REPLACEMENT (SA305)

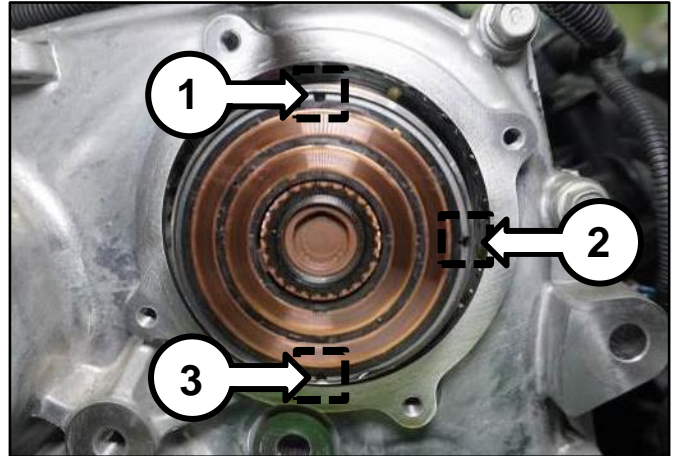
7. Rotate the E-CVVT assembly by hand until the three holes are aligned as shown.

- Hole 1 at the top (12 o'clock)
- Hole 2 at 45 degrees of Hole 1
- Hole 3 at 90 degrees Hole 1

Place a clean shop towel at the bottom of Hole 3. Then using brake cleaner with a straw attachment, insert the straw into Hole 1 and carefully spray for approximately thirty (30) seconds.

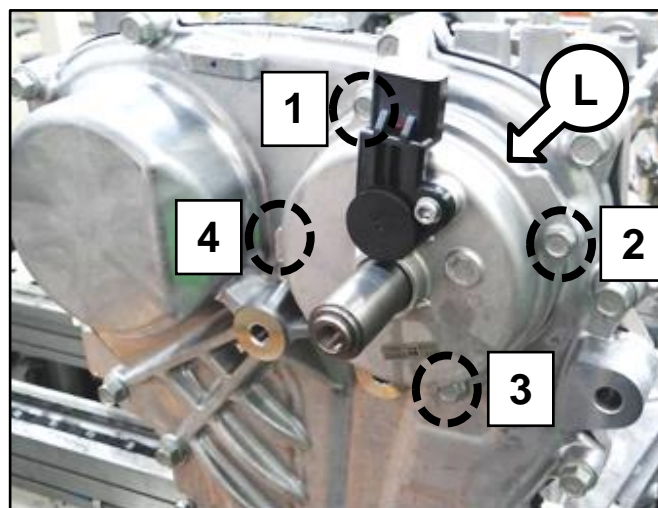
- Install the E-CVVT cover (L) and perform initial tightening sequence of the E-CVVT cover to the specified torque in the sequence below.

**Tightening torque:  
8.4 – 16.8 lb.in (1.0 – 2.0 N.m)**

Tighten the retaining bolts in this sequence: 1 → 3 → 4 → 2
