SERVICE BULLETIN

Classification: EL15-002e	Reference: NTB15-009e	Date: July 13, 2017
------------------------------	--------------------------	------------------------

NAVIGATION SYMPTOMS WHEN SD CARD IS MISSING OR WRONG CARD INSTALLED

APPLIED VEHICLES: 2015-2017 Murano (Z52)
2016 Murano Hybrid (Z52)
2016-2017 LEAF (ZE0)
2016-2017 Maxima (A36)
2017 GT-R (R35)

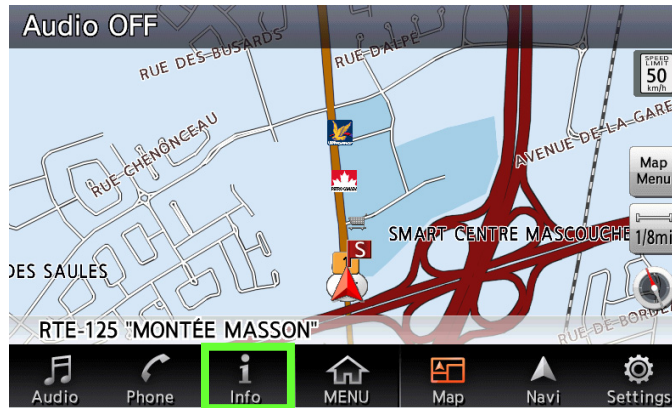
Figure 2

a. Select **Info**.

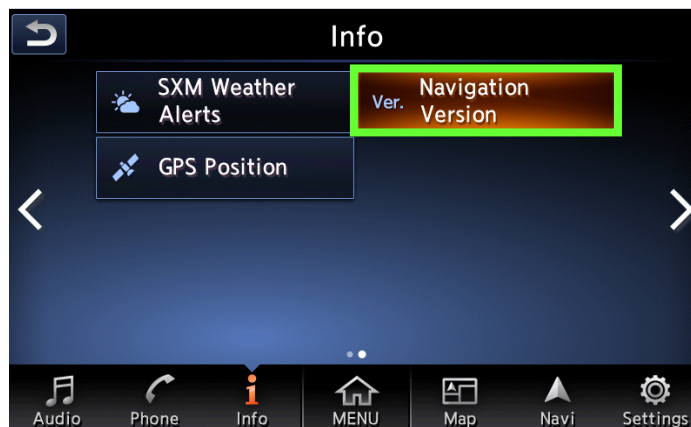
Figure 3

b. Select **Navigation Version**.

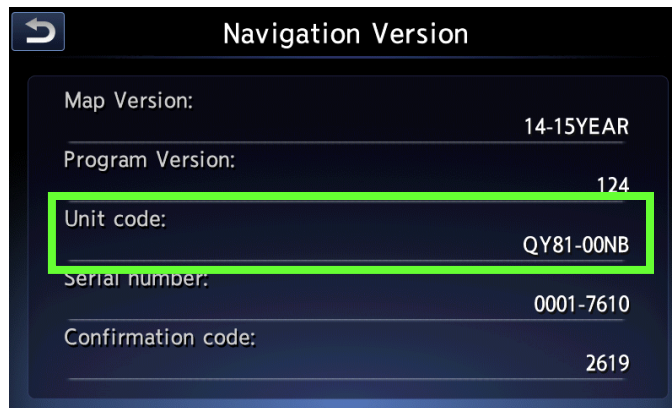
Figure 4

- c. Check "Unit code".

- d. Refer to **SD Card Numbers by Unit Code** table starting on the next page to confirm or choose the correct SD card part number by Unit code.

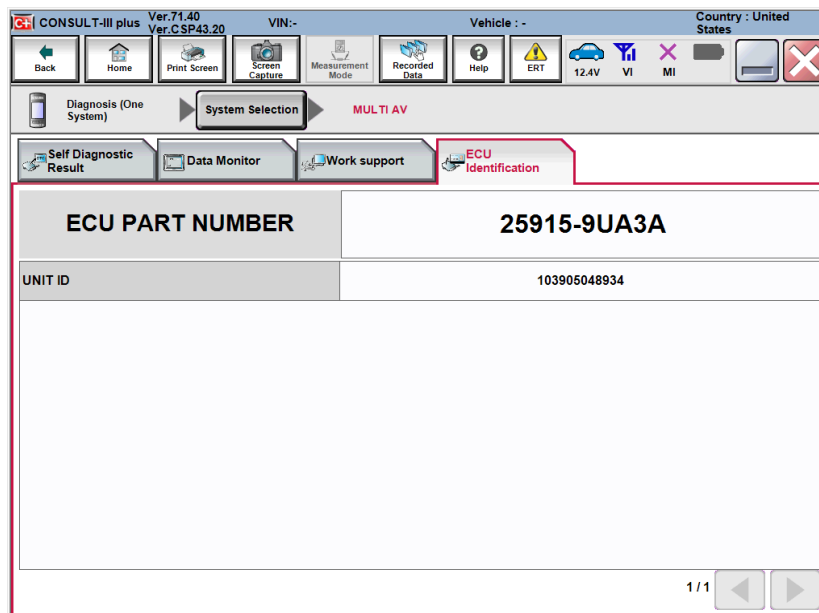
Figure 5

1. Check the ECU Part Number with CONSULT-III plus under **Diagnosis(One System) / MULTI AV / ECU Identification**.

NOTE: If the A/V unit has been removed from the vehicle the ECU Part Number can be found on the external label of the A/V unit.

2. Refer to **SD Card Numbers by Unit Code** table starting on the next page to confirm or choose the correct SD card part number by ECU Part Number.

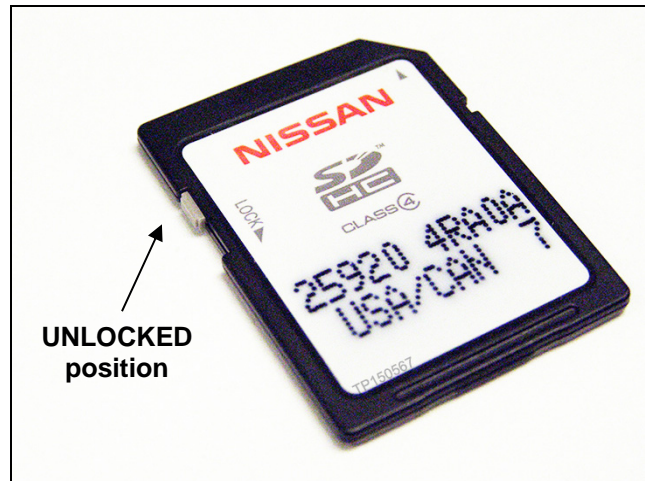
Figure 6

2. Confirm the new Map SD Card is in the "UNLOCKED" position. See Figure 6.

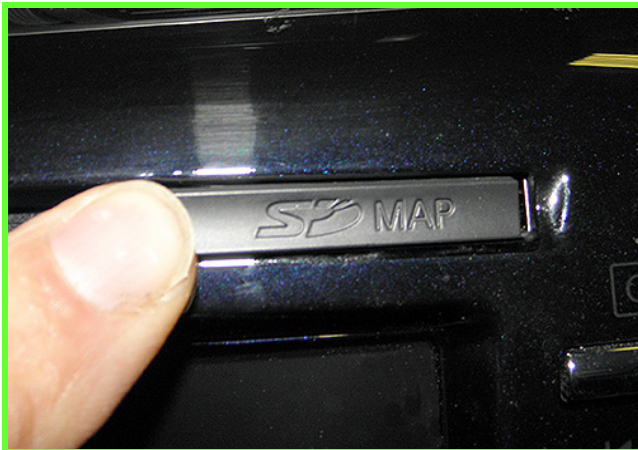
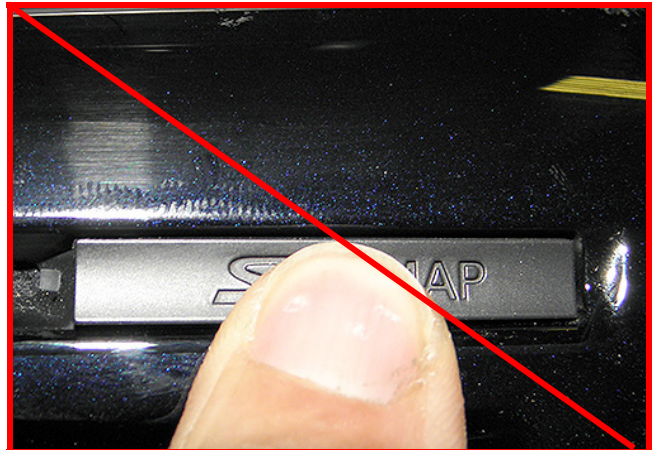
Figure 8

3. Insert the new Map SD Card into the Navigation/audio unit's SD card slot (Figure 8).

- Do not touch the gold colored terminals.
- When closing SD card cover, do not push from the center. This may cause the card to partially eject.

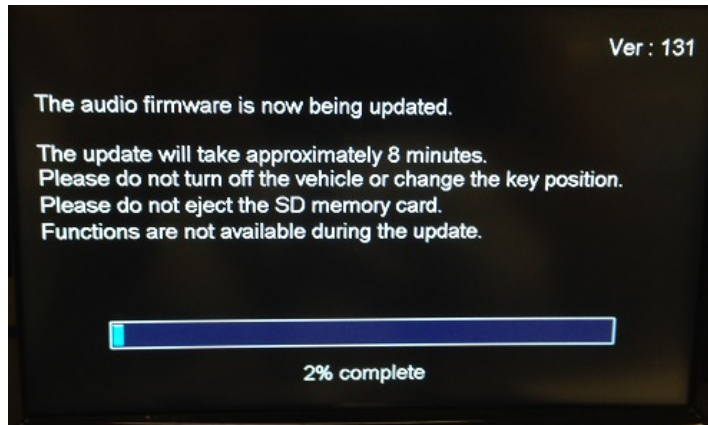
5. The update will start automatically. Confirm that the screen in Figure 9 is present.
- During the update several other similar screens will also be displayed.
 - The total update will take approximately 15 minutes to complete.

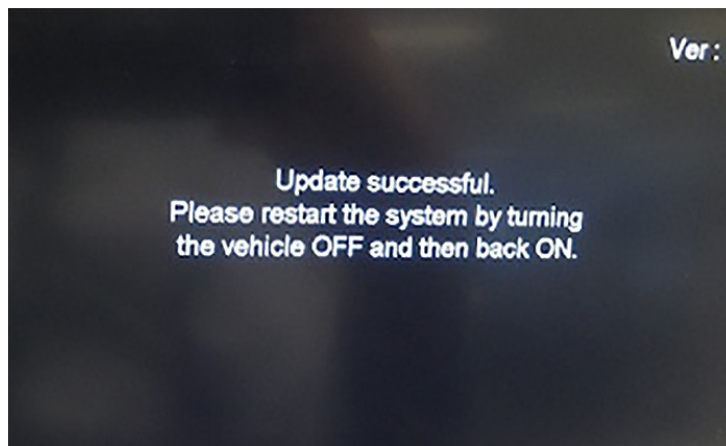
6. When the update has completed, the screen in Figure 10 will be displayed.
