SERVICE BULLETIN

Classification: HA16-004a	Reference: NTB16-112a	Date: July 12, 2017
------------------------------	--------------------------	------------------------

2013-2017 ALTIMA; A/C DOES NOT BLOW COLD AND CLUTCH DOES NOT ENGAGE

APPLIED VEHICLES: 2013-2017 Altima Sedan (L33)

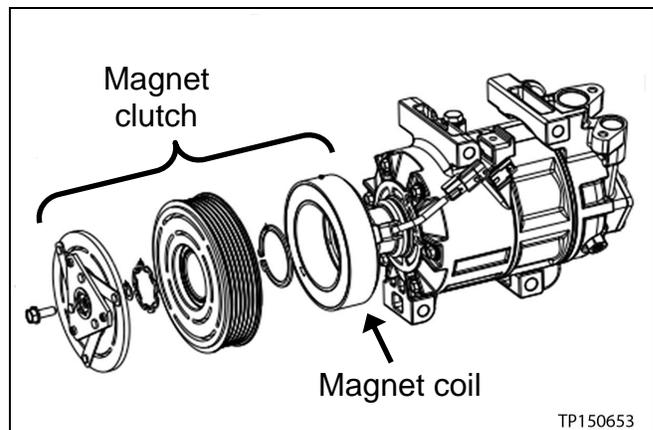
Figure 1

The air conditioner does not blow cold air,

The magnet clutch is determined to be the cause when following the diagnosis procedure in the **HAC** section of the Electronic Service Manual (ESM).

Replace the magnet coil.

NOTE: Do NOT discharge the refrigerant or remove the A/C compressor for this procedure.
